Chichester City Walls.

Outline History:

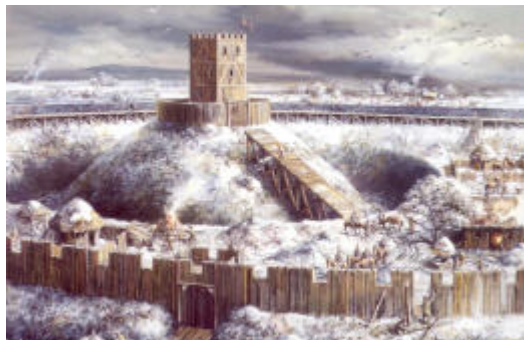
Chichester - A rather fanciful reconstruction of the early timber motte and bailey castle, located in the area that became the Friary, seen in the north-east corner of the Speed map.

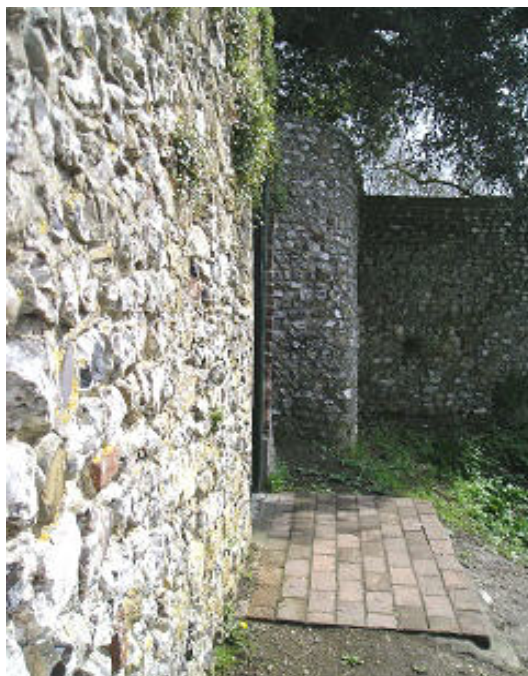
Left. An entrance, adjacent to the wall on the left, to the environs of the Bishop's Palace Garden. Beyond the entrance is a small section of wall that is more likely to be somewhere nearer the original thickness. This section has some original regularly laid Roman coursing stone at its base. It highlights just how much facing stone and flint has been robbed over the years, and the section of wall nearest has lost at least two feet compared to the end section.

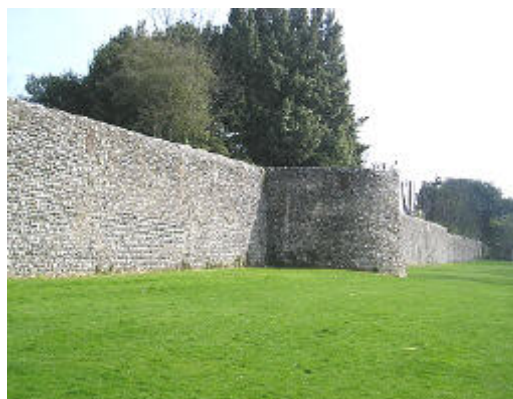
Above: Christchurch town wall in the south-west quadrant, north of the River Lavant, looking south-east.
