Arundel

1. Arundel

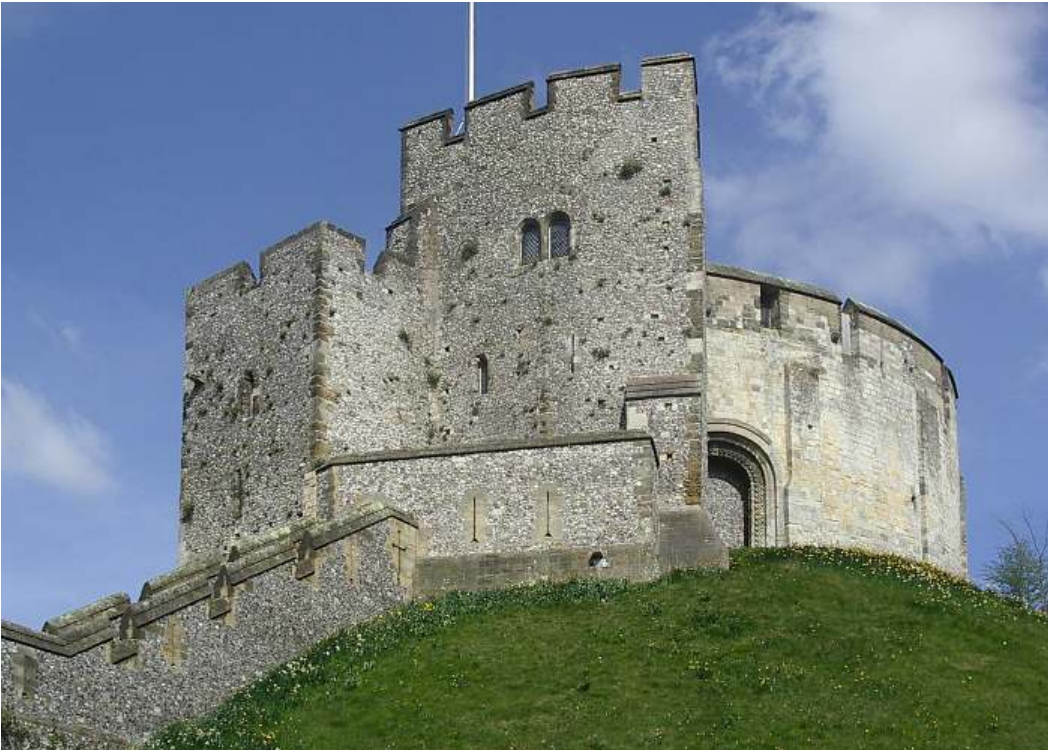
Fig. 1. Arundel Castle. The shell-keep, well tower and forebuilding from the south-east (lower bailey). The original Norman door is half-hidden by the later forebuilding.

Another potential problem is the large and ornate Romanesque doorway adjacent to (but not incorporated into) the forebuilding. Long assumed to have been the original entrance, superseded (and so blocked) when the forebuilding was added, its total decorative authenticity has been queried by Derek Renn and Neil Guy (Woodburn 2005-2006a, 24). Stylistically odd in having no capitals or imposts to its arch, it appears in no pictorial sources before the early 19th century, but may have been completely hidden by ivy. It has clearly been comprehensively renovated, perhaps in the 19th century. Its enhanced form being in direct view of the occupied residences in the bailey below suggests it was made into a significant architectural feature. Was it originally inspired by d'Albini's Castle Rising?

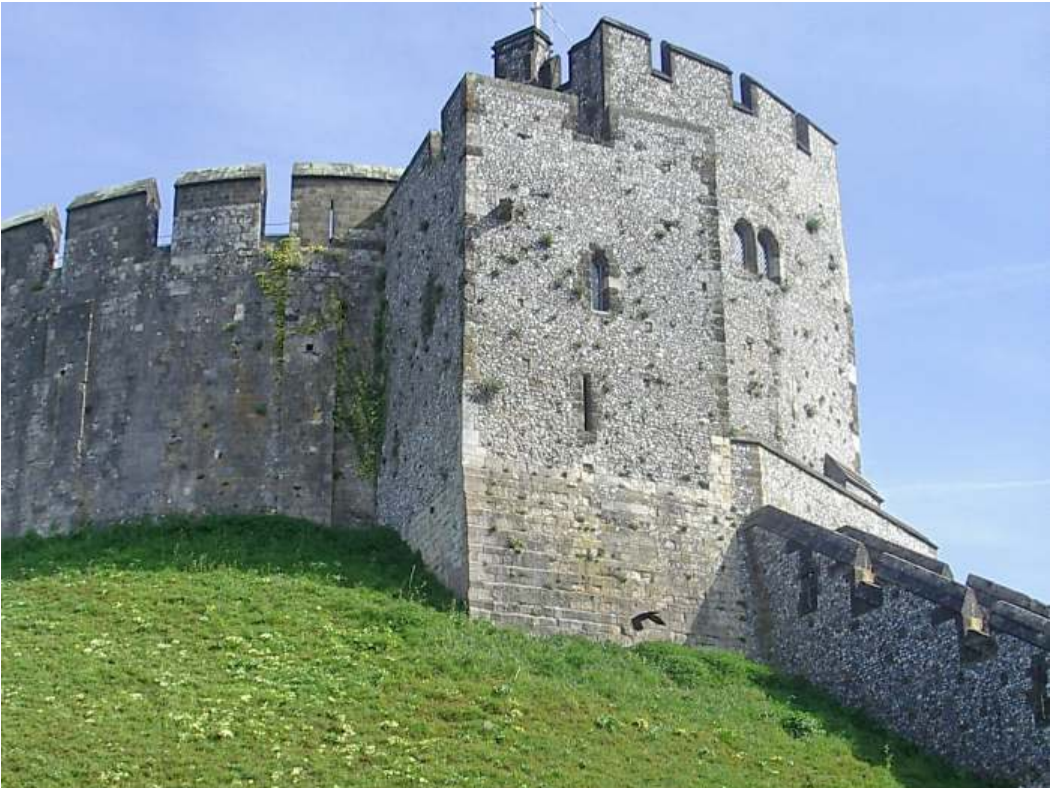
Fig. 2. Arundel Castle. The shell-keep from the south-west. Well tower (left) and forebuilding.

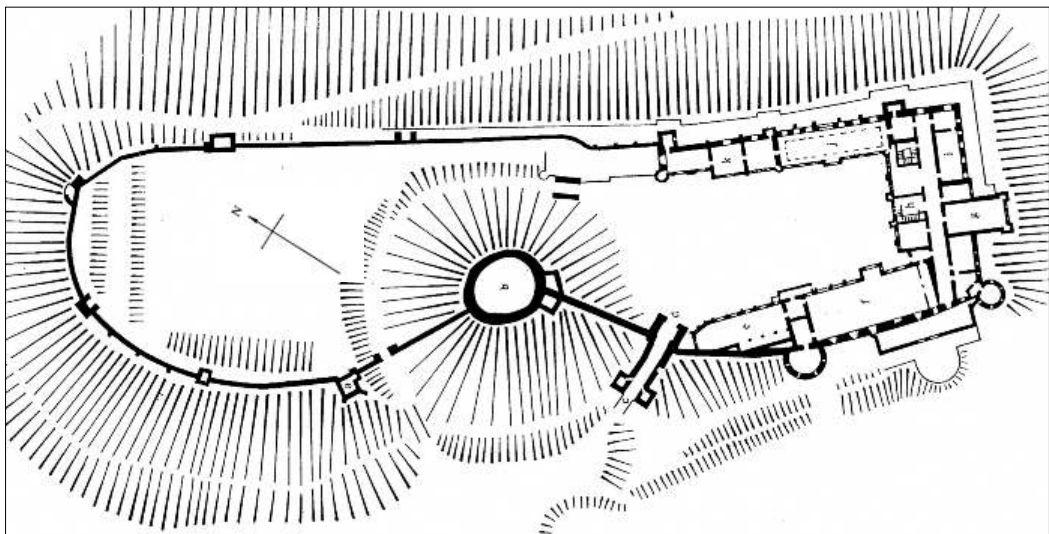
ABOVE: Fig. 3. Arundel Castle - plan, with central oval motte and shell-keep. © VCH - Sussex: *A History of the County of Sussex: Vol. 5 Part 1, Arundel Rape:South-Western Part*, 1997. Retrieved via British History Online: <http://www.british-history.ac.uk/sites/default/files/publications/pubid-103/images/fig07.gif> Reproduced with thanks.

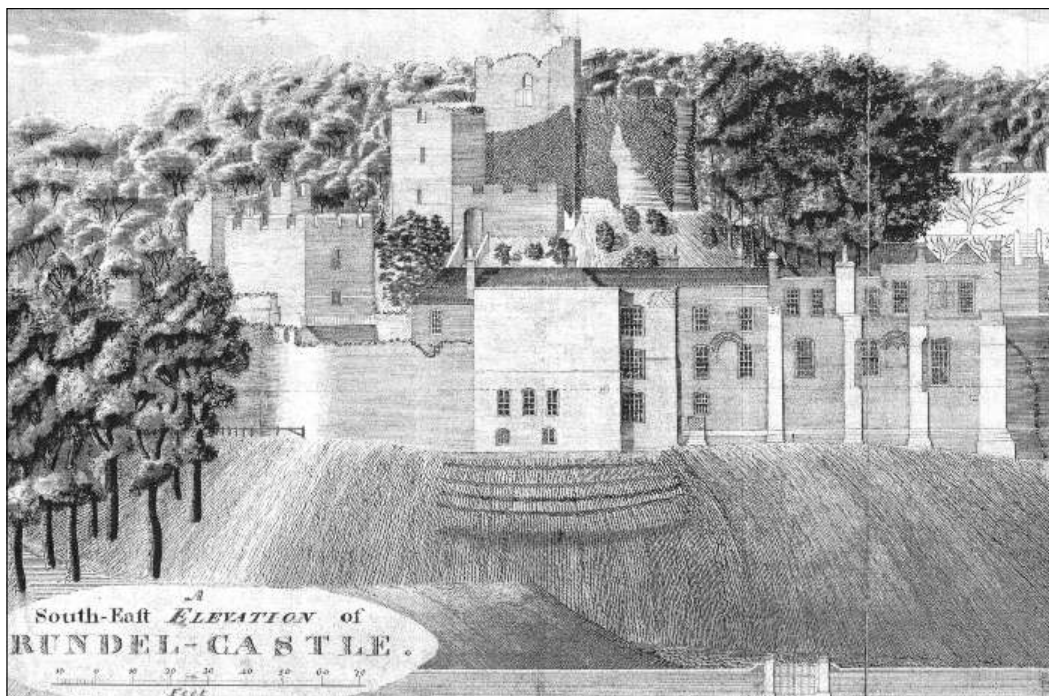
BELOW: Fig. 4. Shell keep from the south-east. Engraving dating to the 1780s from a survey done for the 10th Duke of Norfolk, just before the restoration of the south bailey buildings by the 11th Duke. There is no obvious drawn evidence for the original door to the right of the forebuilding, but it may be hidden by ivy. Ref Arundel Castle Archives MD 2182. Reproduced by courtesy of Arundel Castle Trustees Ltd.

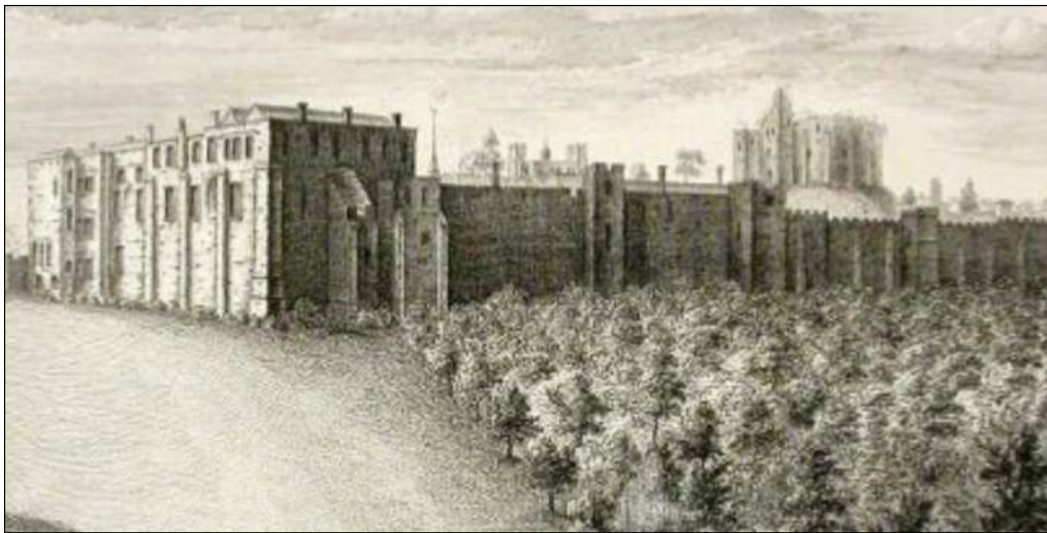
ABOVE: Fig. 5. The Buck Bros. 1747 view of Arundel Castle from the east (detail). The condition of the upper part of the shell- keep forebuilding is similar to that shown below in the 1780 print.

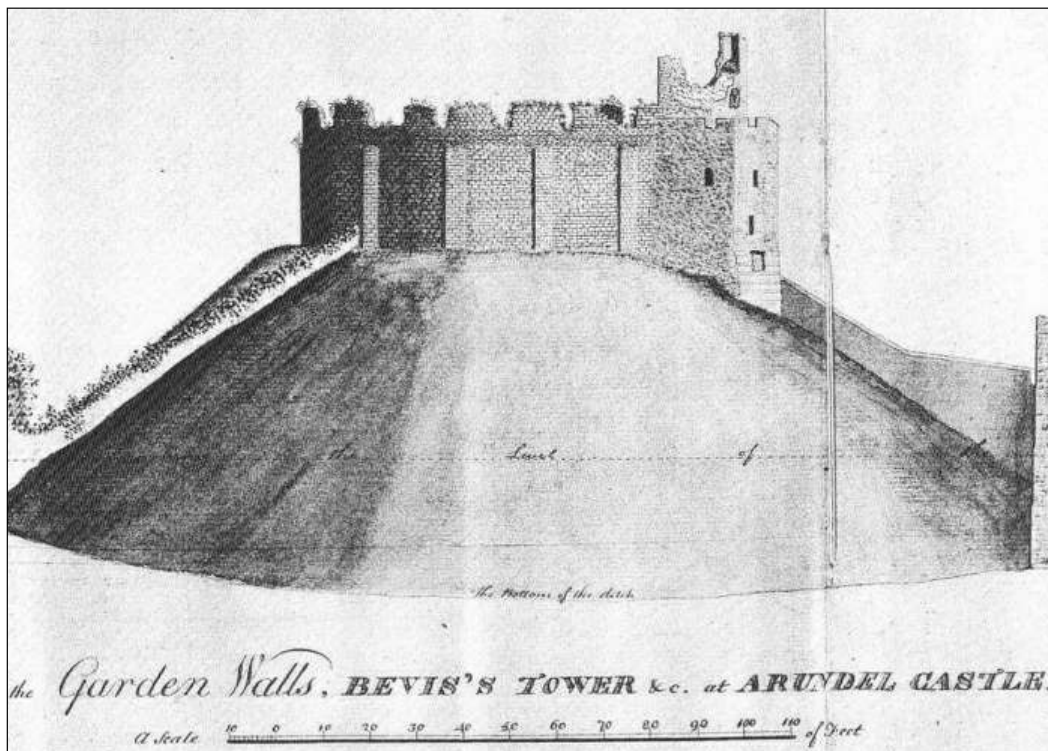
BELOW: Fig. 6. Profile drawing of the west side of Arundel shell-keep (detail). From a survey of 1780. "An elevation of the Keep, the Gateway, the Garden Walls, Bevis Tower etc At Arundel Castle, facing towards the south-west". The state of the parapet crenellations should be compared to fig. 7 where the new different coloured masonry stands out. Reproduced by courtesy of Arundel Castle Trustees; Ref: Arundel Castle Archives MD 2182.

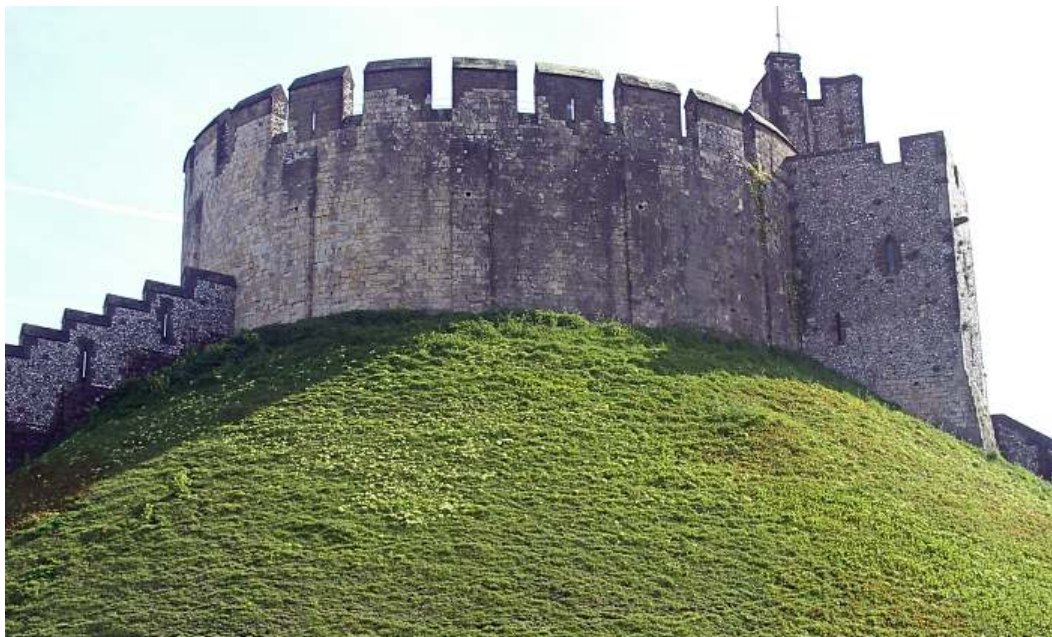
Fig. 7. Arundel Castle shell-keep and well tower from the west. The early morning light highlights the colour contrast in the stonework in the reconstructed tops of the merlons.

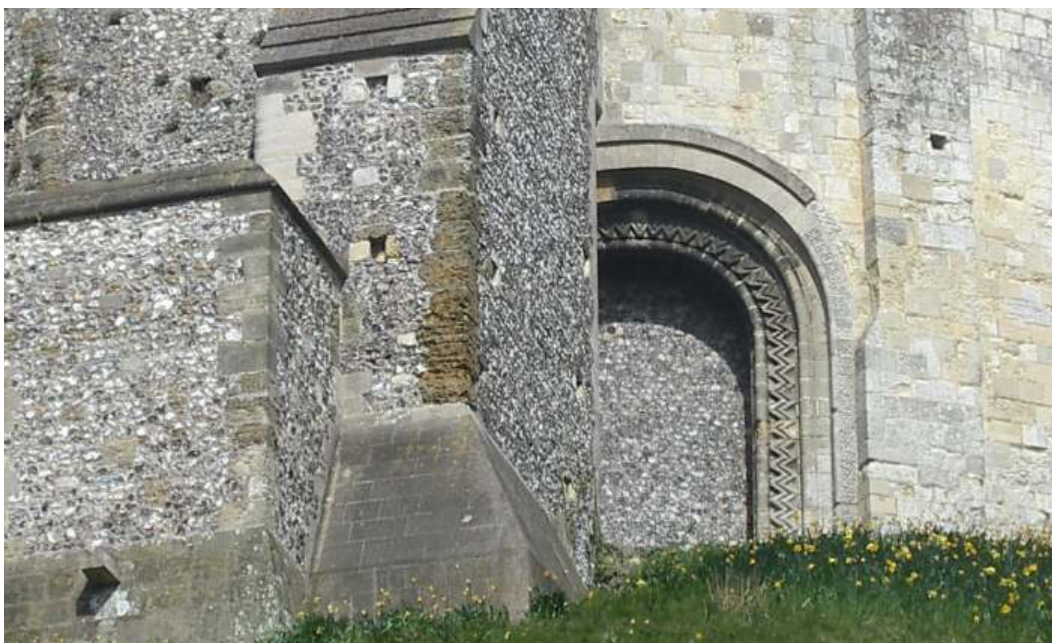
Fig. 8. Detail of the partly rebuilt forebuilding and location of the original (now blocked) Norman entrance, perhaps c. 1140. (See fig. 16 for the detail of the interior side of the same entrance). The double chevron motif around the door was also a known and popular motif in East Anglia - perhaps a d'Albini influence at Castle Rising church, Castle Rising castle; also at Castle Hedingham, in the 1140-50s.

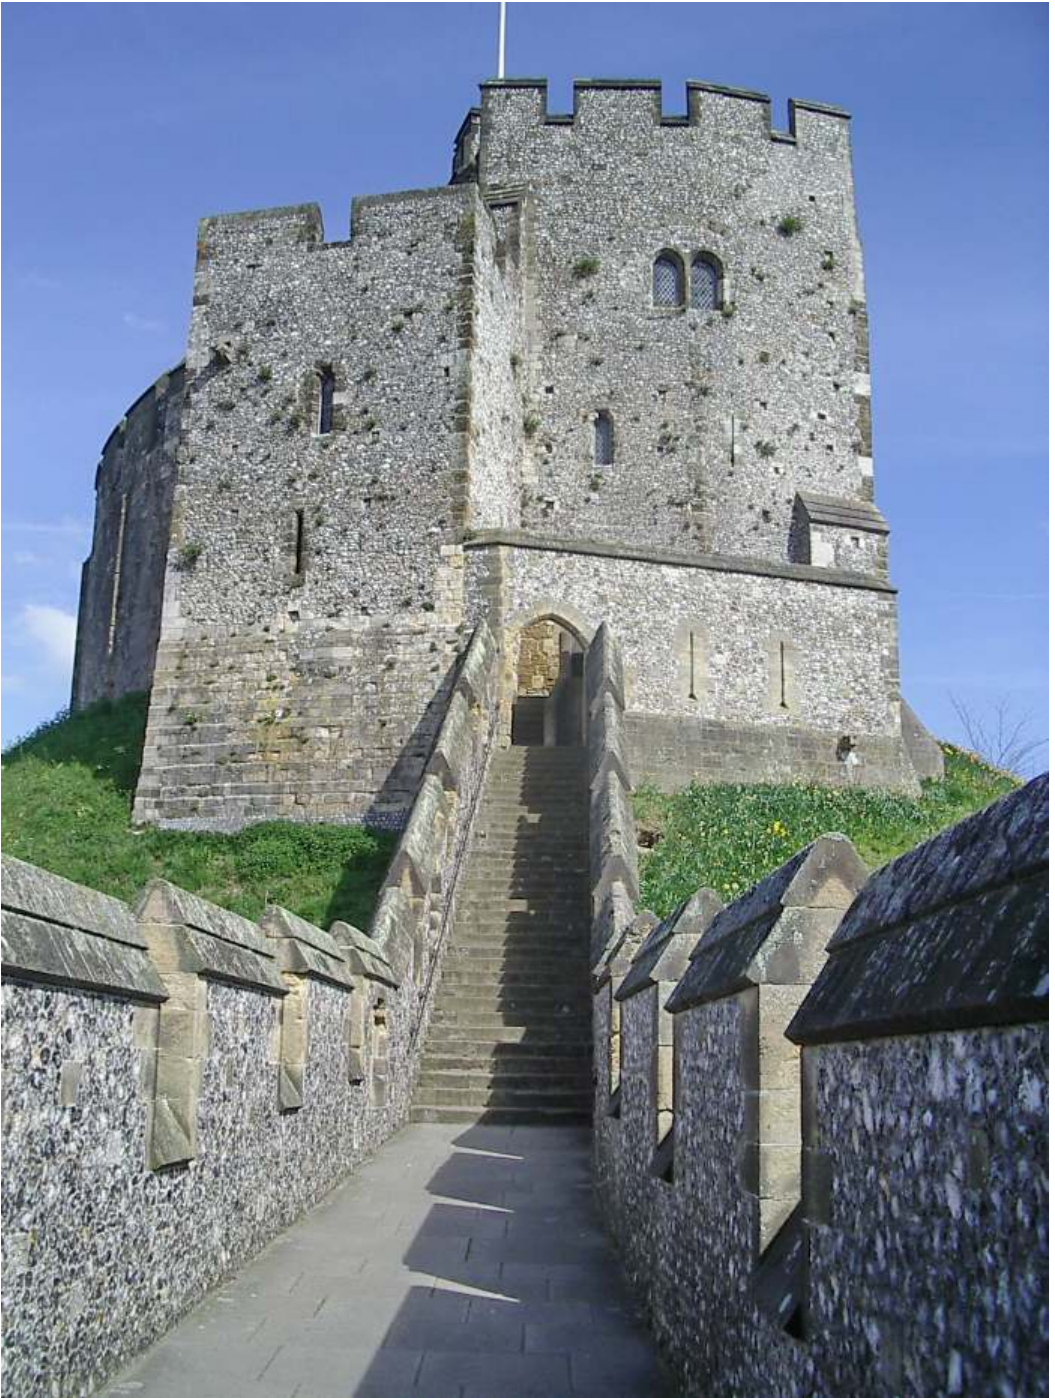
Fig. 9. The steps leading to the forebuilding courtyard with (rebuilt) entrance through the outer screen wall. Much of the forebuilding to the left of and including the twin-lancet windows above the first storey appears to have been rebuilt in the late 19th or early 20th century.

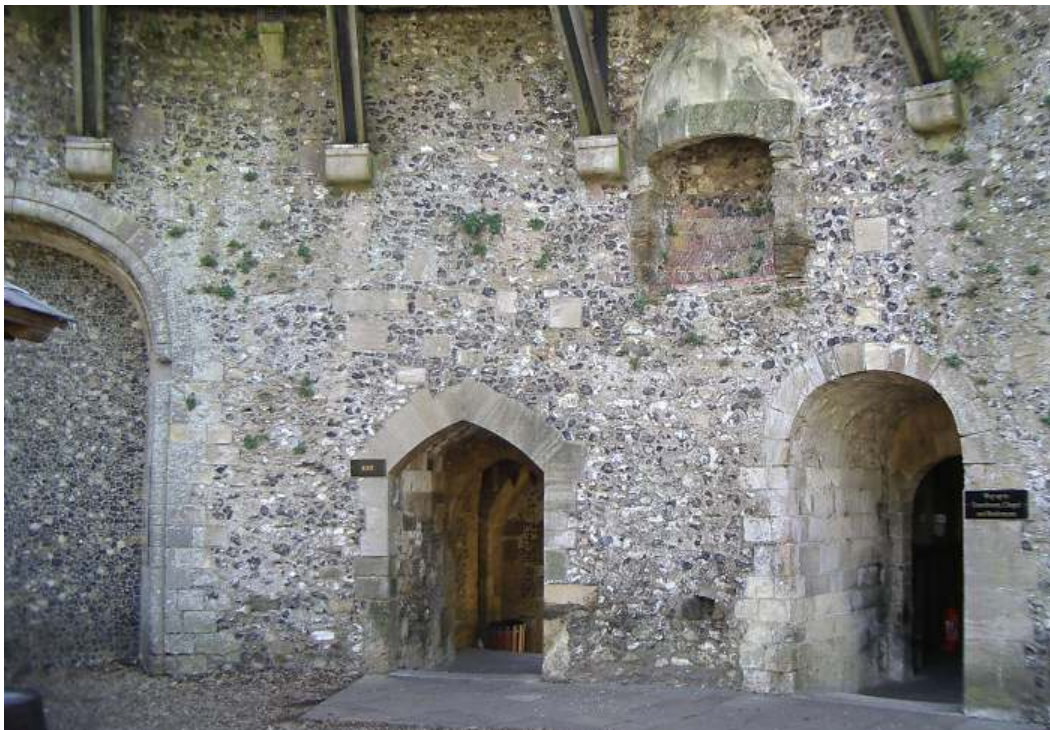
ABOVE: Fig. 10. Keep interior facing south-east. Original entrance (far left); present entrance from forebuilding with low pointed arch and entrance to the guardroom / chapel on the right. Fireplace above (see fig. 19).

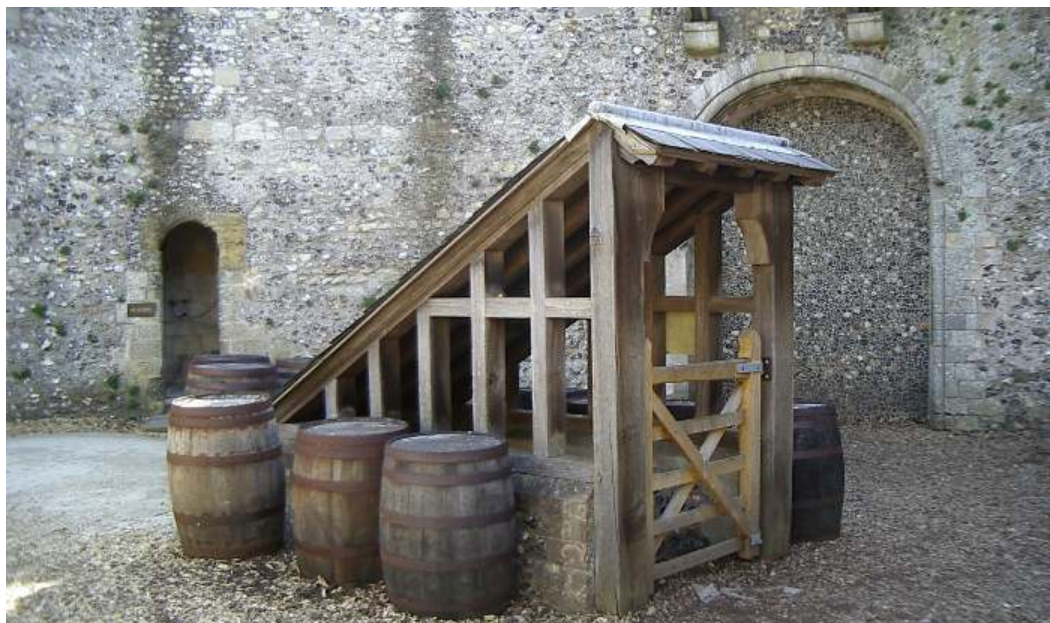
BELOW: Fig. 11. Interior looking east. Modern cover to subterranean rib-vaulted store within the motte. Entrance to wall-walk stairs to rear left. Corbelling may be modern to support the widened wall-walk.

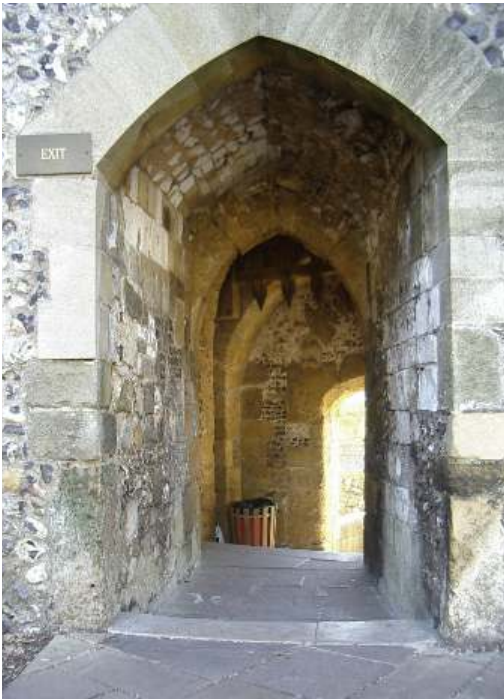
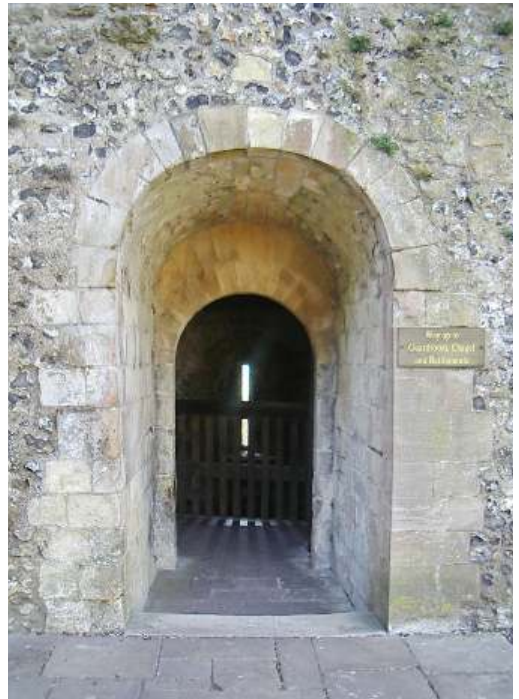
BELOW: Figs. 13, 14. Keep interior. Left: Entrance defended by a mini-portcullis worked from the chamber above within the forebuilding (modern reproduction portcullis and mechanism). Right: Entrance to guardroom, chapel and wall-walk battlements.

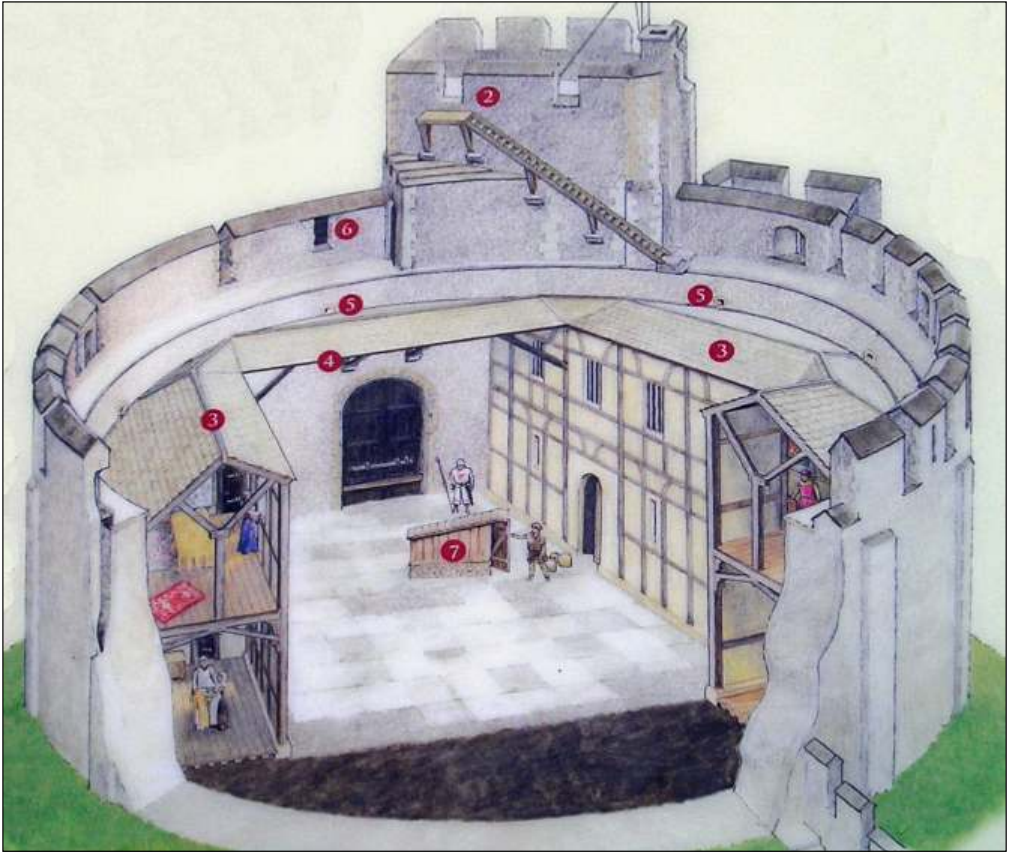
ABOVE: Fig. 15. Photograph of the on-site display panel in the shell-keep. (The reconstruction is also in the Robinson guidebook). The legend suggests it represents the keep 'as it might have looked in 1190' (cf. Windsor). The view is from the north looking toward the original entrance, which is now blocked. That may indicate that the battlemented forebuilding, in its earliest phase, may have been a solar tower (cf. Tamworth), rather than an entrance lobby. It would seem unusual and impractical for the forebuilding entrance to lead directly into the wooden-framed accommodation suite as illustrated above in that location.

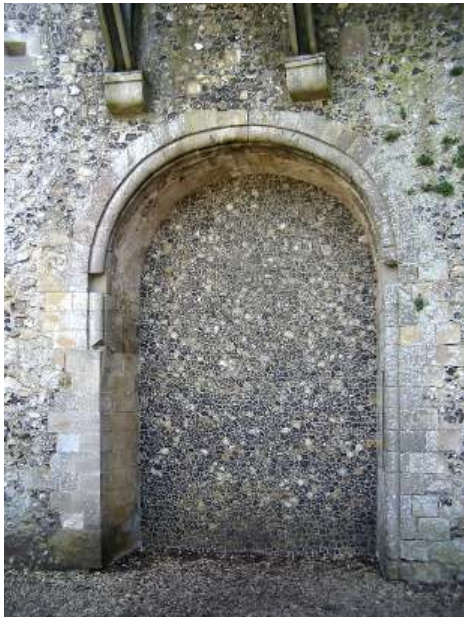
LEFT: Fig. 16. Interior side of the original entrance. The lower left-hand side of the arch has lost its roll moulding, replaced by featureless ashlar blocks. This may explain the damage, made good, after the lower arch was presumably removed (fig. 18). The function / purpose of this arch is undetermined. The exterior of the same doorway is shown in fig. 8. It is unclear how much of the exterior mouldings are original. Perhaps the present sections of plain ashlar, undecorated, deliberately emphasise and indicate new work.

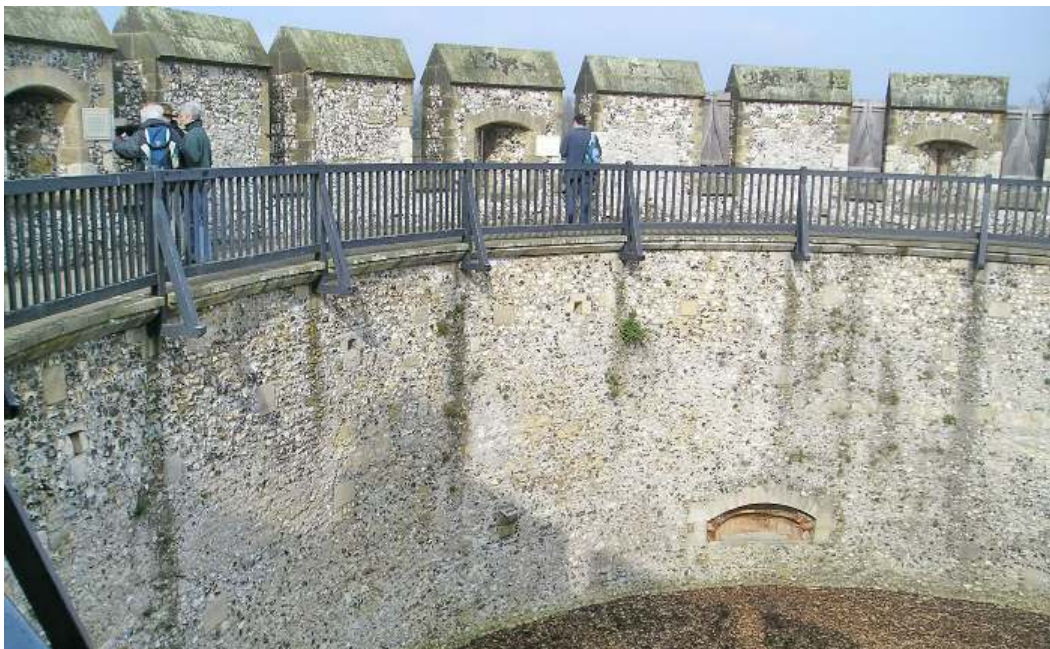
ABOVE: Fig. 17. Shell-keep interior and wall-walk looking north-west; arch and recess for an oven?

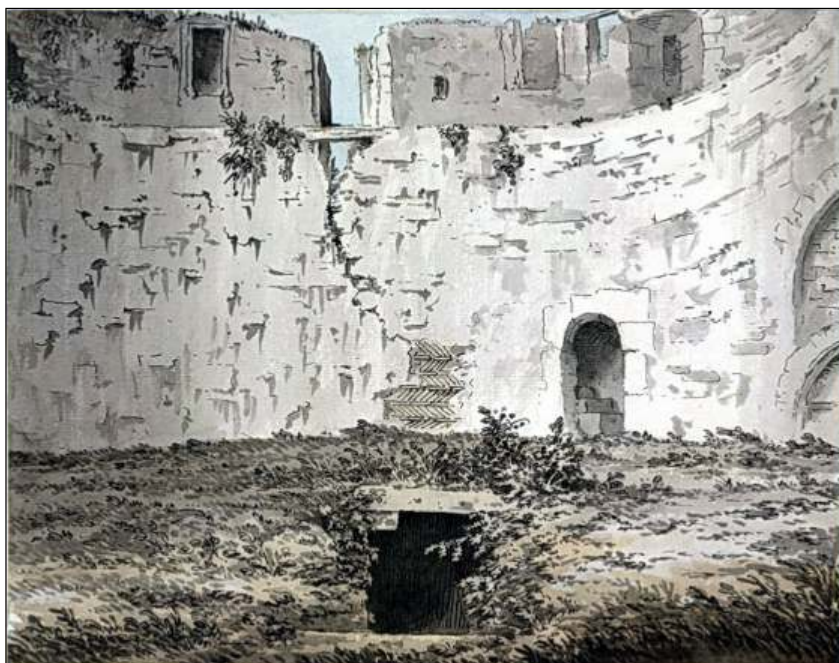
BELOW: Fig. 18. Drawing of the shell-keep interior in c. 1780. By S. H. Grimm. © British Library Board, Shelfmark, Additional MS 5674, f. 26 (n. 45). Reproduced with thanks. Grimm shows the steps down into the underground store in the middle of the courtyard, the entrance into the steps that lead up to the wall-walk, and to the right, the original blocked keep entrance, with a second, lower arch for which there is now no trace.

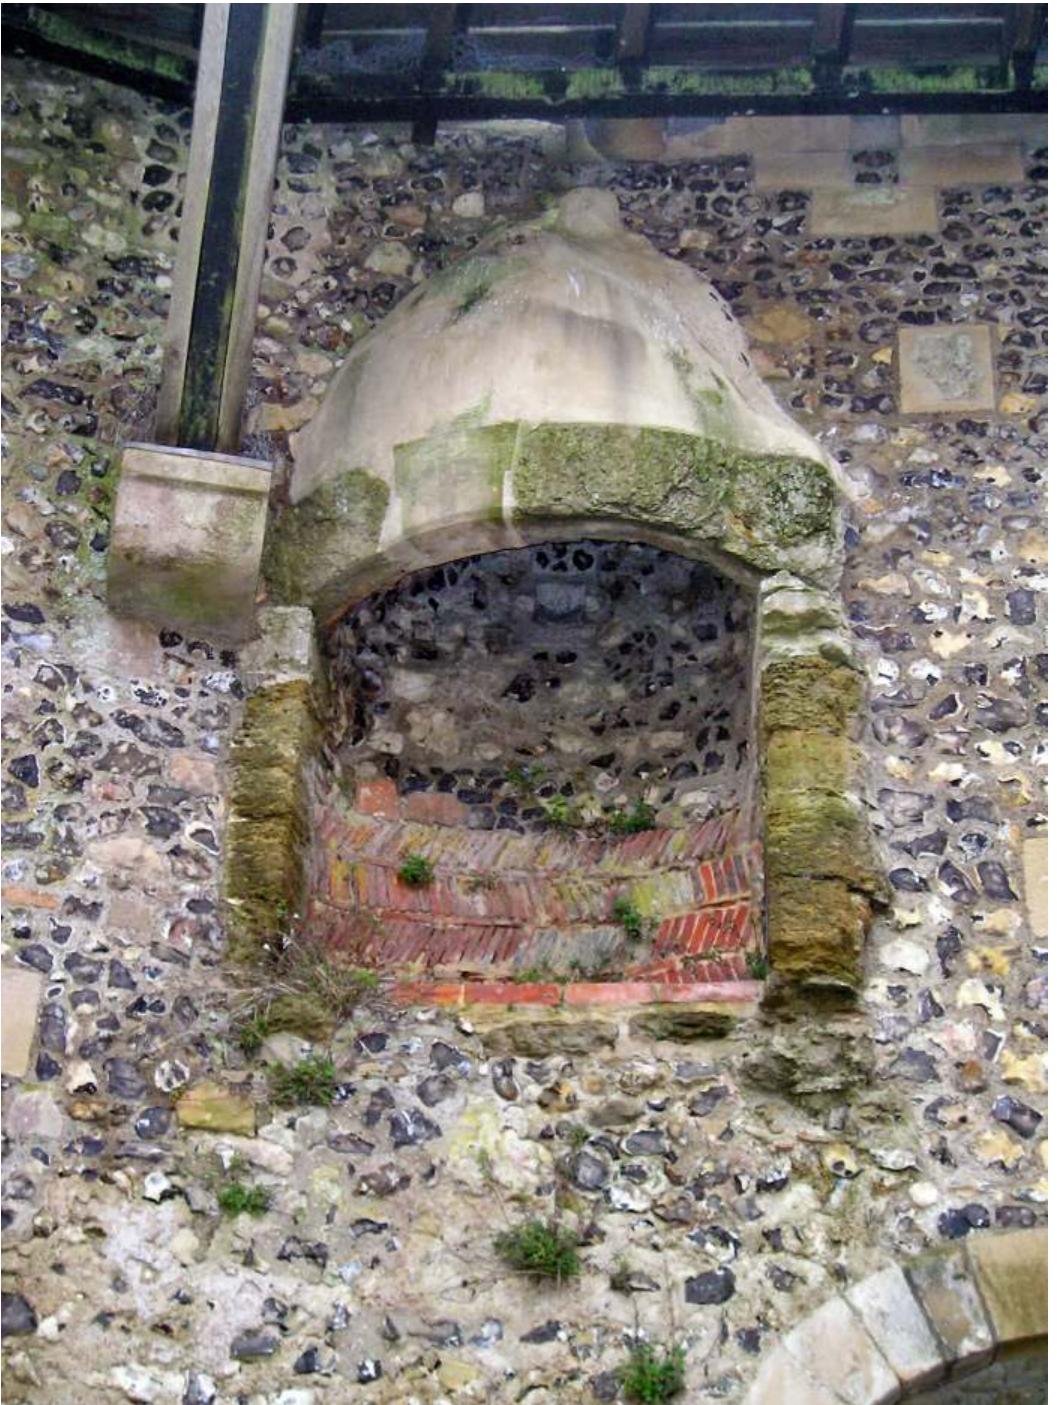
Fig. 19. Detail of the hooded fireplace with curving back and herring-bone tiled fire-back. A similar fireplace is located at Ogmere Castle, dated to early-mid C12 illustrated in RCAHMW, Early Castles, Part 1a, p. 283.
