2. Berkeley

Published interpretations of the shell-keep have assumed the following sequence: (a) the motte was part of the castle of William fitzOsbern, documented in the late 11th century, bearing a structure of which no trace now remains; (b) with the assent and direction of Henry II in 1154, the new owner, Robert fitzHarding (a rich Bristol merchant, from an English family, who supported the Angevin cause and died in 1170) truncated the motte-top, encased the motte in a shell-keep with battered plinth, a series of pilaster buttresses, (probably) four semi-circular "bastions" and (soon afterwards) a forebuilding with defended stair rising from ground level to a doorway on the motte-top, the latter being leveled up with the spoil created by truncating the motte; (c) this shell-keep rose above the motte, with domestic buildings against its inside face - all now gone except for the apse of a chapel in the north-east "bastion"; (d) these domestic structures were replaced during a major 14th-century rebuilding of the whole castle by Thomas III Berkeley (died 1361); (d) to this rebuilding relate (i) the Thorpe Tow-

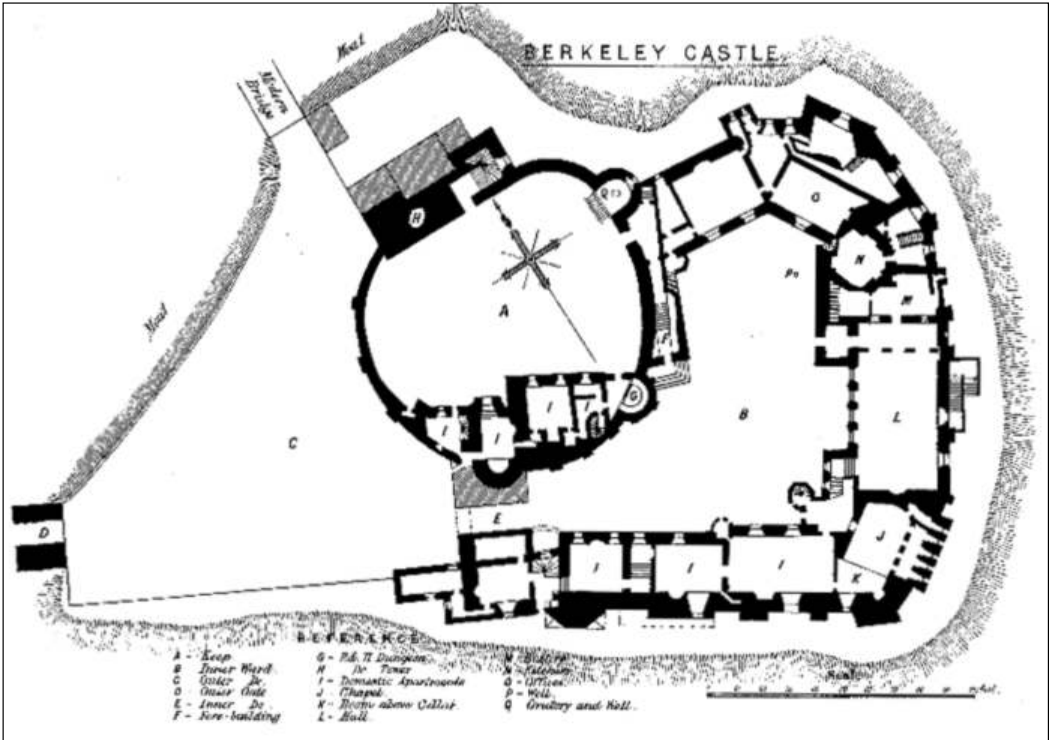
Fig. 1. Plan of Berkeley Castle prepared for G. T Clark, published in Vol. 1 of *Mediaeval Military Architecture*, 1884, opposite. p. 229.

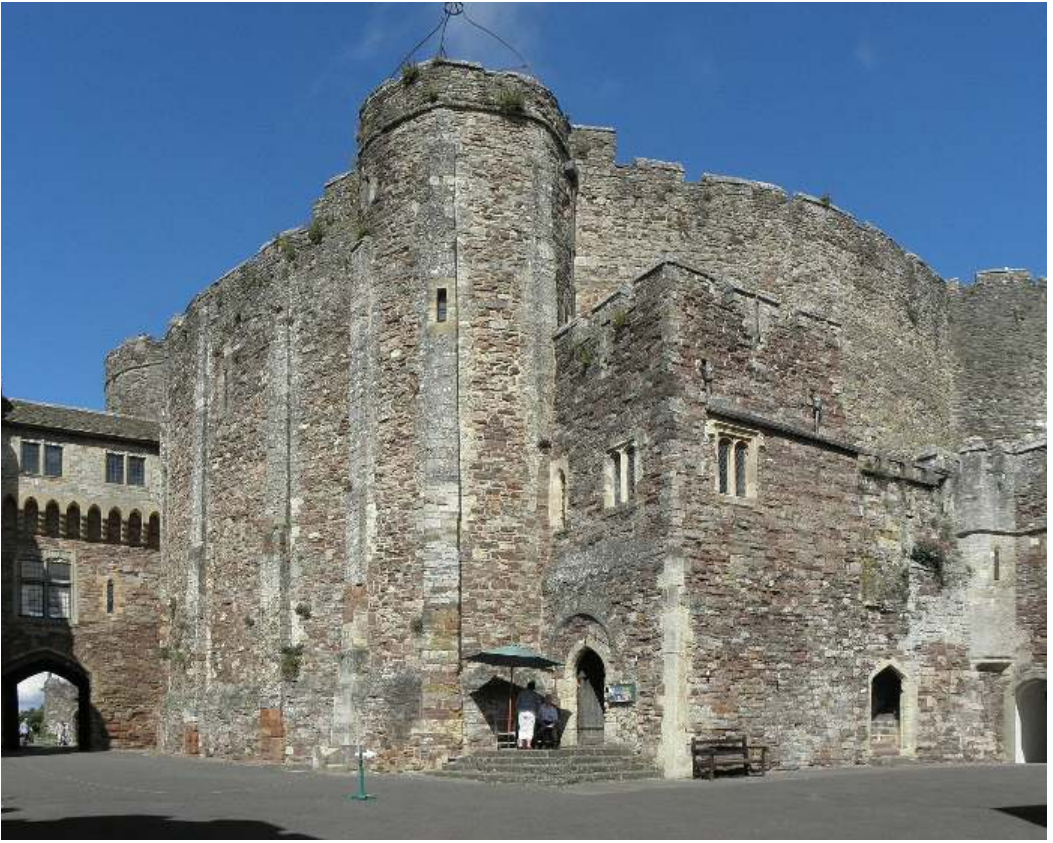
Fig. 4. Berkeley. The shell-keep from the inner bailey, from the south. The lobed or half-round tower adjacent to the forebuilding is integral to the wall of the shell.

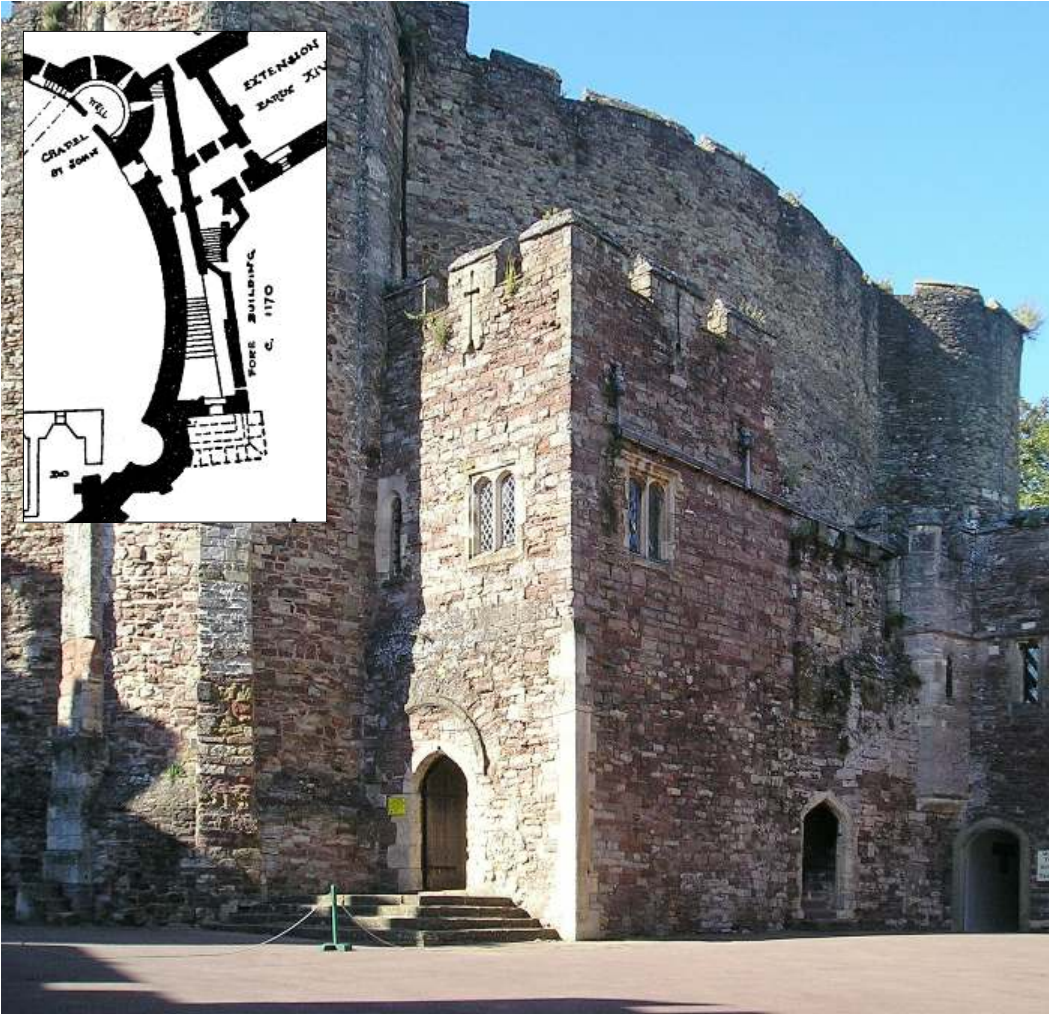
Fig. 5 (& Inset). Detail of the south-east face of the shell-keep showing two of the round 'bastions' or turrets; that on the right containing the chapel. It is possible that the forebuilding and stairs have been re-aligned or straightened and that the steps were narrower at the base, once curving up concentrically to the entrance.

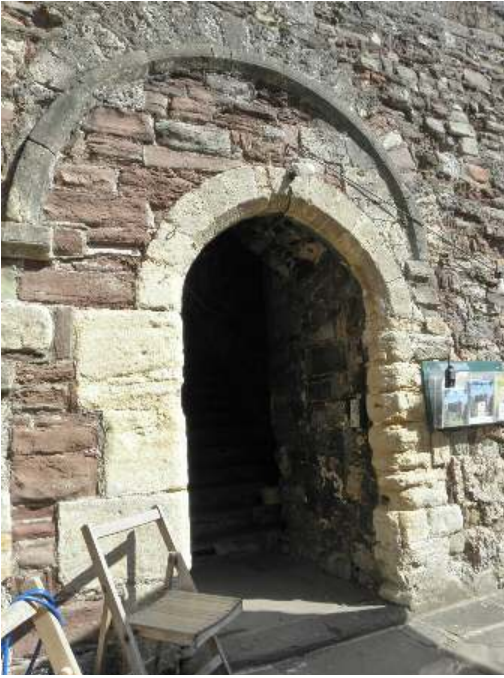
Fig. 7. Lower forebuilding entrance from the bailey. With original hood moulding above the (now) off-centre entrance.

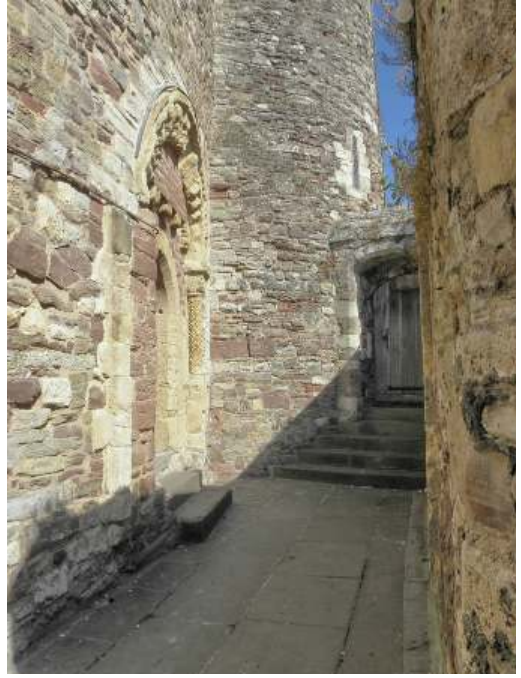
Fig. 8. Top of the forebuilding stairs with keep entrance to the left. To L & R are narrow jambs that supported the drawbridge when closed.

At the top of the forebuilding, an impressive Romanesque doorway has a round-headed arch of three orders with double chevron and zig-zag design, and a (surviving, right) column with a design based on interlace foliage supporting a foliate capital. Even this impressive structure, however, is not easy to interpret. Some of its fabric disappeared in the 14th century when it was part in-filled to take a narrower door: its left column and tympanum were casualties. But the surviving column is remarkably short in relation to the height of the doorway: even allowing that the present level at the top of the steps is lower than the original thresholds. While it is impossible to be certain, it could easily be a column re-used from some other building: if so, how old was it when placed here? The change in threshold level is evident not only from the main doorway but also from the intermediate one, near the top of the stairs, whose bases are high and whose jambs - with flat faces on the downside, bevelled edges on the upside and no sign of door hangings - suggest it may at some point have been related to a tilting draw-bridge.

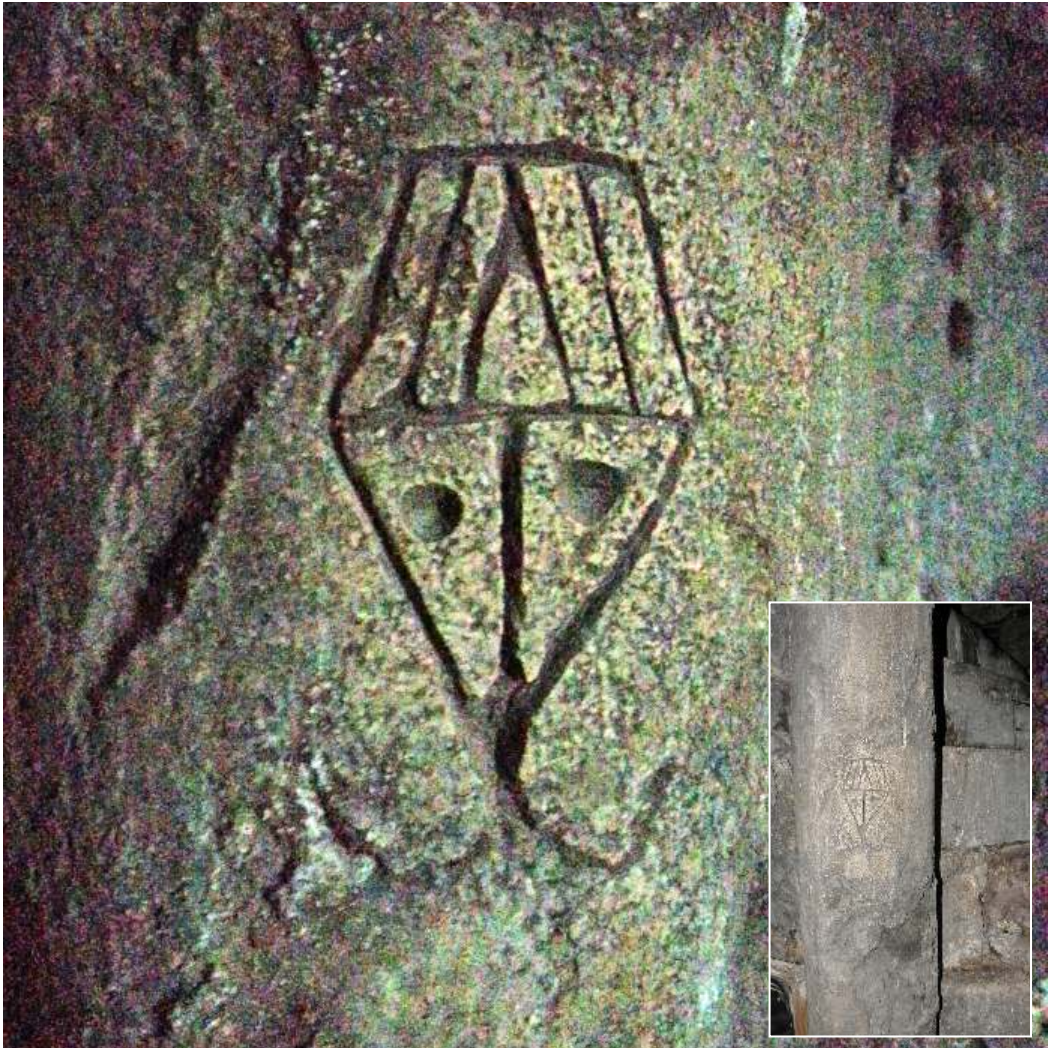
Fig. 9 (& Inset). Detail of the (probably impossible to date) pot-helm graffito. Pot helms were used after the 1180s. The inset image locates the graffito on the newel of the spiral stairs in the east tower of the Thorpe Tower, approx 14 cms height x 10 cms max width.

ABOVE: Fig. 11. The Thorpe Tower from the interior of the shell-keep, looking north. The round-arched entrance from the shell-keep courtyard may post-date the medieval period. The east tower (right) contains the vaulted spiral stair that contains the putative medieval graffito (fig. 9).

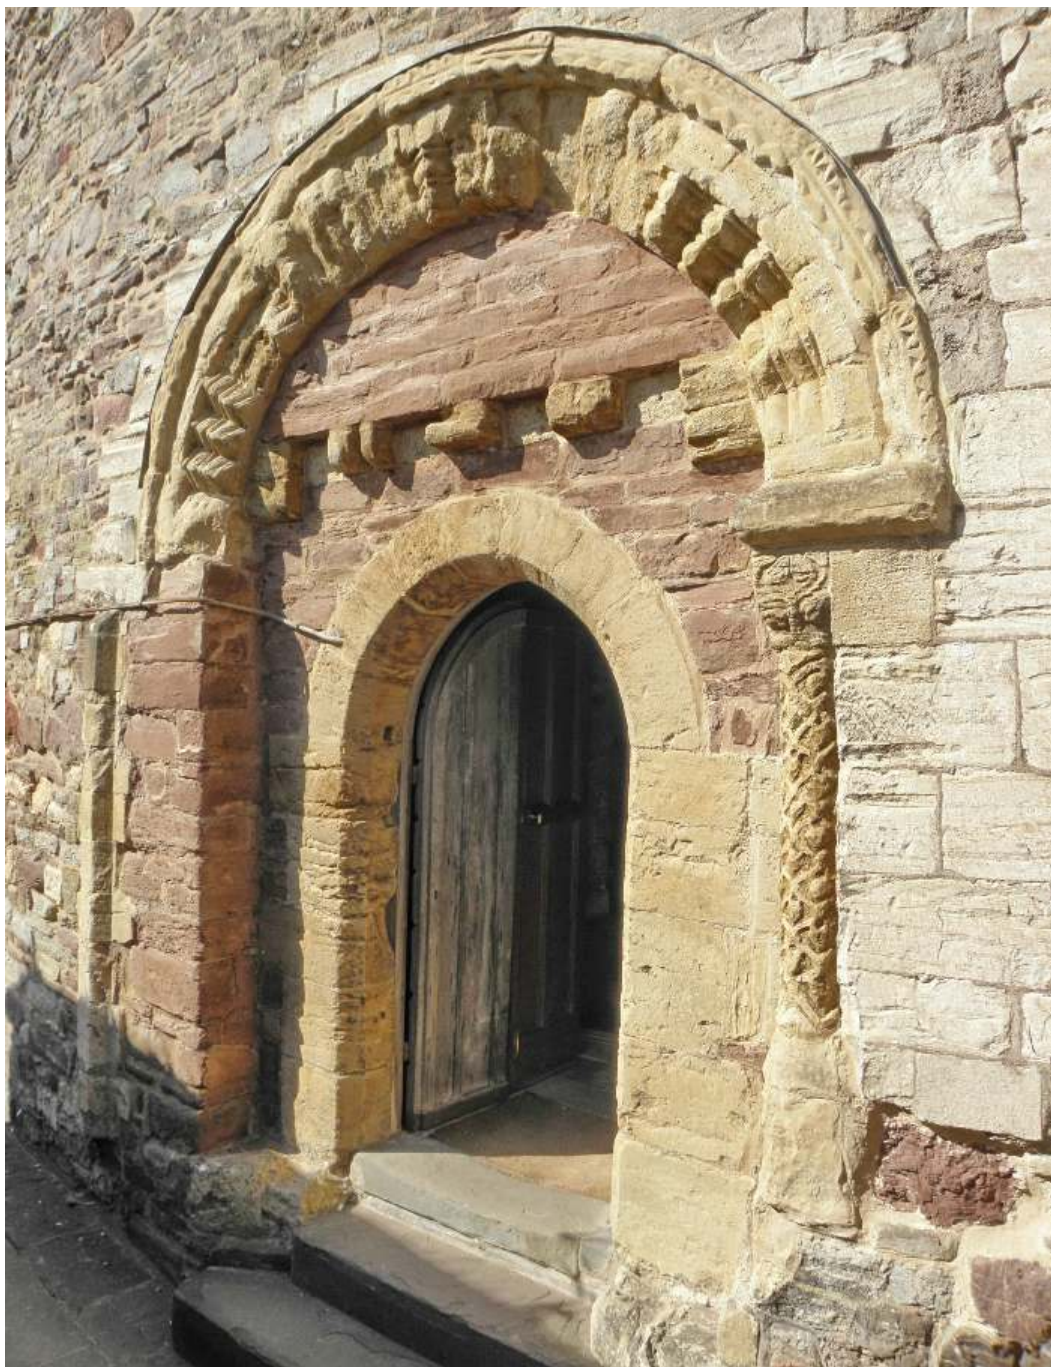
Fig. 10. The Romanesque doorway with round-headed arch of three orders, bold chevron design, and a (surviving, right) column with design based on interlace foliage supporting a foliate capital. The column is remarkably short in relation to the height of the doorway: even allowing that the present level at the top of the steps is lower than the original thresholds. While it is impossible to be certain, it could be a column re-used from some other building.

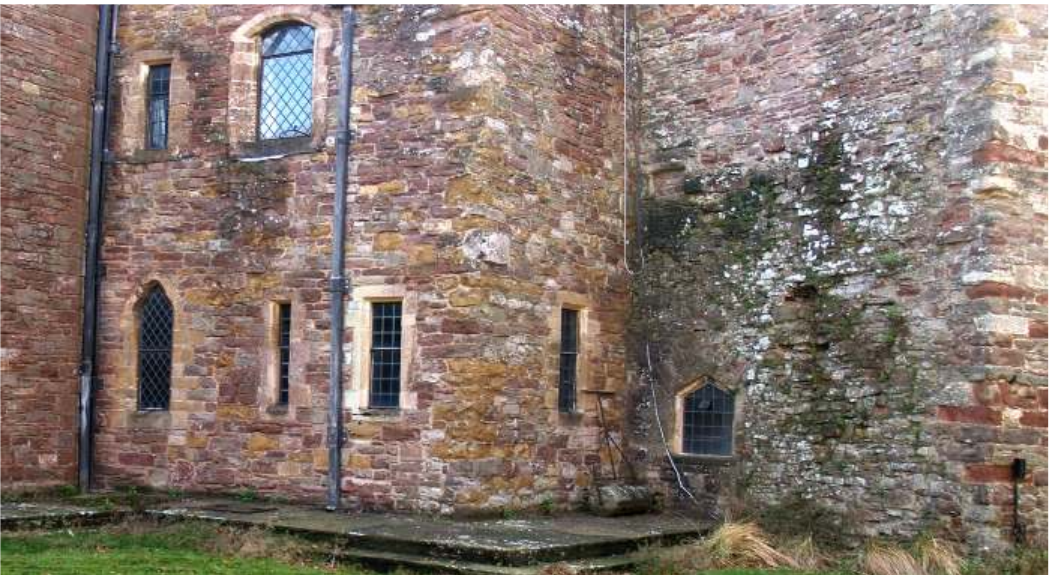
BELOW: Fig. 12. The altered west end of a range of domestic buildings on the south side of the shell-keep courtyard. The buildings have traces of 12th-century work. The early 14th century low pointed-arch window (near the lawn roller) may have been a door, which is on axis with the chapel (see plan - fig 2) and follows the line of the transverse arcade wall.

tions. Recent structural survey by John Thorp revealed survival of much 14th-century fabric within this south range, but the range has been so heavily remodelled between the 16th and 20th centuries that detailed reconstruction of the 14th-century arrangements is as impossible as it is for their presumed 12th-century predecessors. It seems very likely, however, that in the 14th century - and quite possibly in the 12th century - ranges of two-storey buildings occupied much of the internal face of the shell-keep on this (south) side. One socket for a large timber may survive in the face of the shell wall just outside the western end of the domestic range.

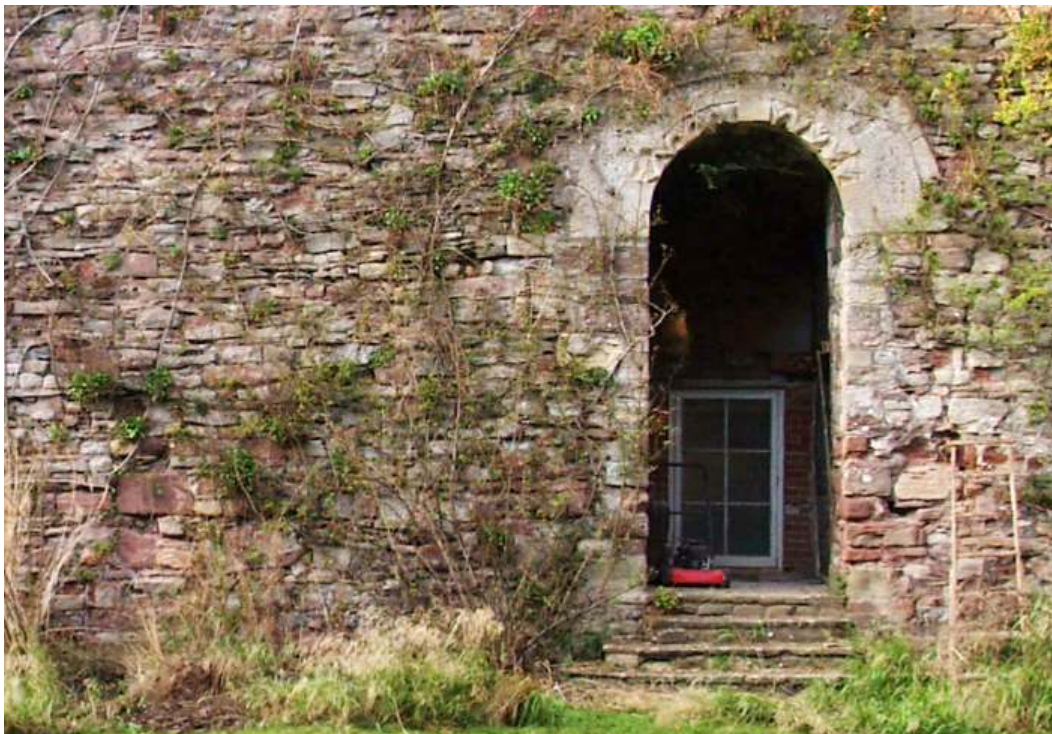
ABOVE: Fig. 13. Detail of the round-arched entrance to the Thorpe Tower from the shell keep courtyard. The arch includes fragments of Norman chevron decorated voussoirs, which may have come from elsewhere.

The "phasing" of the castle, in terms of observable architectural features, must be approached with extreme caution. The passageway - itself probably knocked through in the 18th century - opening from the Thorpe Tower onto the shell-keep interior has been heightened in modern times and has had 12th-century details added which probably came from elsewhere. The lower entrance into the shell-keep forebuilding also appears to result from a part-reconstruction, even allowing for the 14th-century rebuilding of this structure (involving the addition of its upper storey, the narrowing of the entrance and the new alignment of steps to replace - to judge from the fabric - a stairway running concentric to the curving shell wall). This, in turn, raises another problem: the relationship between the forebuilding and the adjacent "bastion". In its final form, the forebuilding wraps around part of the latter; whether it did so

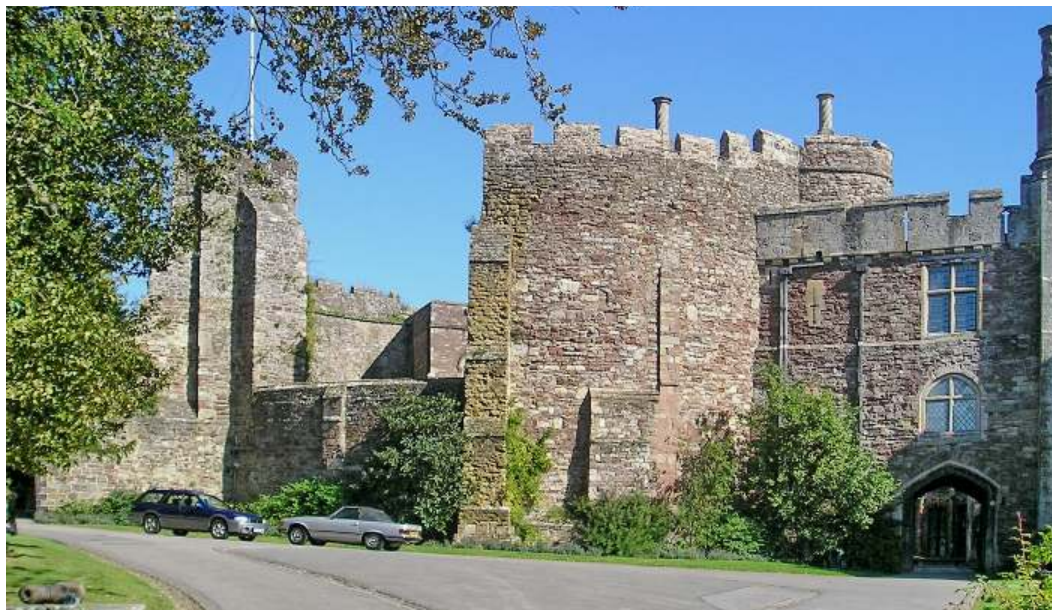
BELOW: Fig. 14. The shell-keep from the west with the gap in the shell wall caused by Civil War artillery. North is the truncated west tower of the Thorpe Tower and behind which is the added 1760s Gothic Revival 'laundry'.

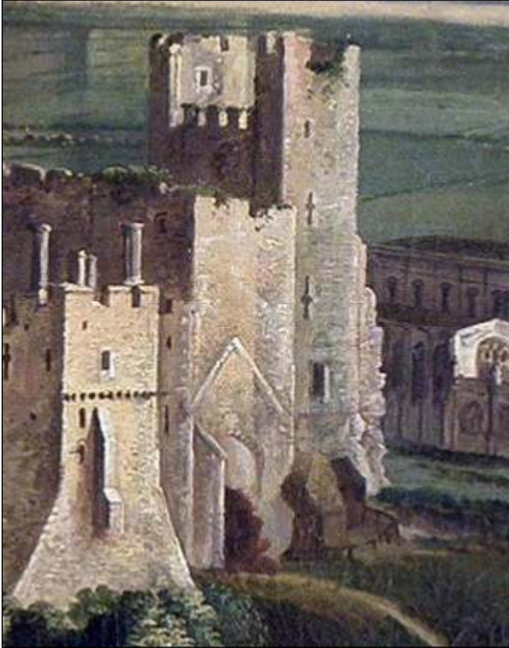
Fig. 15. Detail of the 1670s Knyff painting, from the east, showing the Thorpe Tower's ragged east 'buttress' that may have originally been a truncated wall heading north. It also shows the original heights of the two towers (since reduced).

presumably for stone-throwing engines since 1342 is too early for gunpowder cannon to require such platforms? The fact that they face the church and borough raises, however, a query about whether particular defensibility was required on this side of the castle, though some have noted that this is the side of the castle where the natural defences are weakest. Also (so far) unexplained is the blocked doorway at the uppermost level of the connecting wall. The whole structure was, when first built, a whole storey higher than it now survives. Its original height is shown on paintings of 1676 by Jacob Knyff. The uppermost storey was demolished around 1700, during consoli-

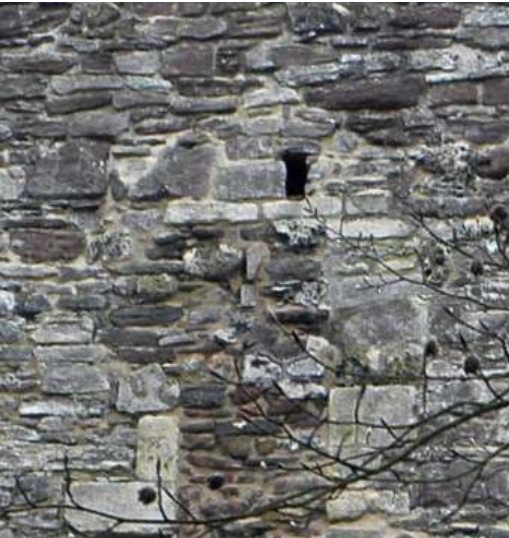
Fig. 17. The suspected blocked doorway in the upper level of the Thorpe Tower, facing north. The other side of this door is viewable from the mural passage that leads from the east to the west tower.

There remain, however, problems. One is a detail of the surviving fabric: if it is an early feature (and not a 14th-century feature giving access to a timber wall-gallery facing north) how did the (blocked) doorway (figs. 17, 18) in the upper level of the Thorpe Tower wall relate to the interior of this putative *donjon*? Another is that we are still left with the issue of what resulted from the documented 14th-century works. Was an earlier structure, larger but ruinous, rebuilt in its entirety, only to be reduced in size later (in the 1640s?). Or was the earlier structure reduced by half its bulk and rebuilt in 1342 more or less as it was until its front side was in-filled in the 1760s? In either event, what was it used for in the 14th and later centuries? Is it what John Leland called the "square dongeon tower". It had lost its northern half before 1676 when it was shown on Knyff's paintings (fig. 15), one of which (but not the other) shows ragged masonry stubs presumably arising from demolition or collapse of fabric.
