16. Trematon

The castle existed by 1086, when Reginald de Valletort held the manor from Robert of Mortain, as it is specifically mentioned in Domesday Book. His descendants held it down to 1270, when the manor and castle were sold to Richard, earl of Cornwall. It has been noted (Burls 2005; Page 2000) that this sale (as well as the sale to Richard of the castle at Cardinham, also in Cornwall, in 1268) may have been made under pressure from this powerful figure, who was seeking to re-establish his reputation and standing after his downfall in the Barons' War of 1264-65. Richard here exploited the circumstances of Cornish families of ancient origin who were now short of cash.

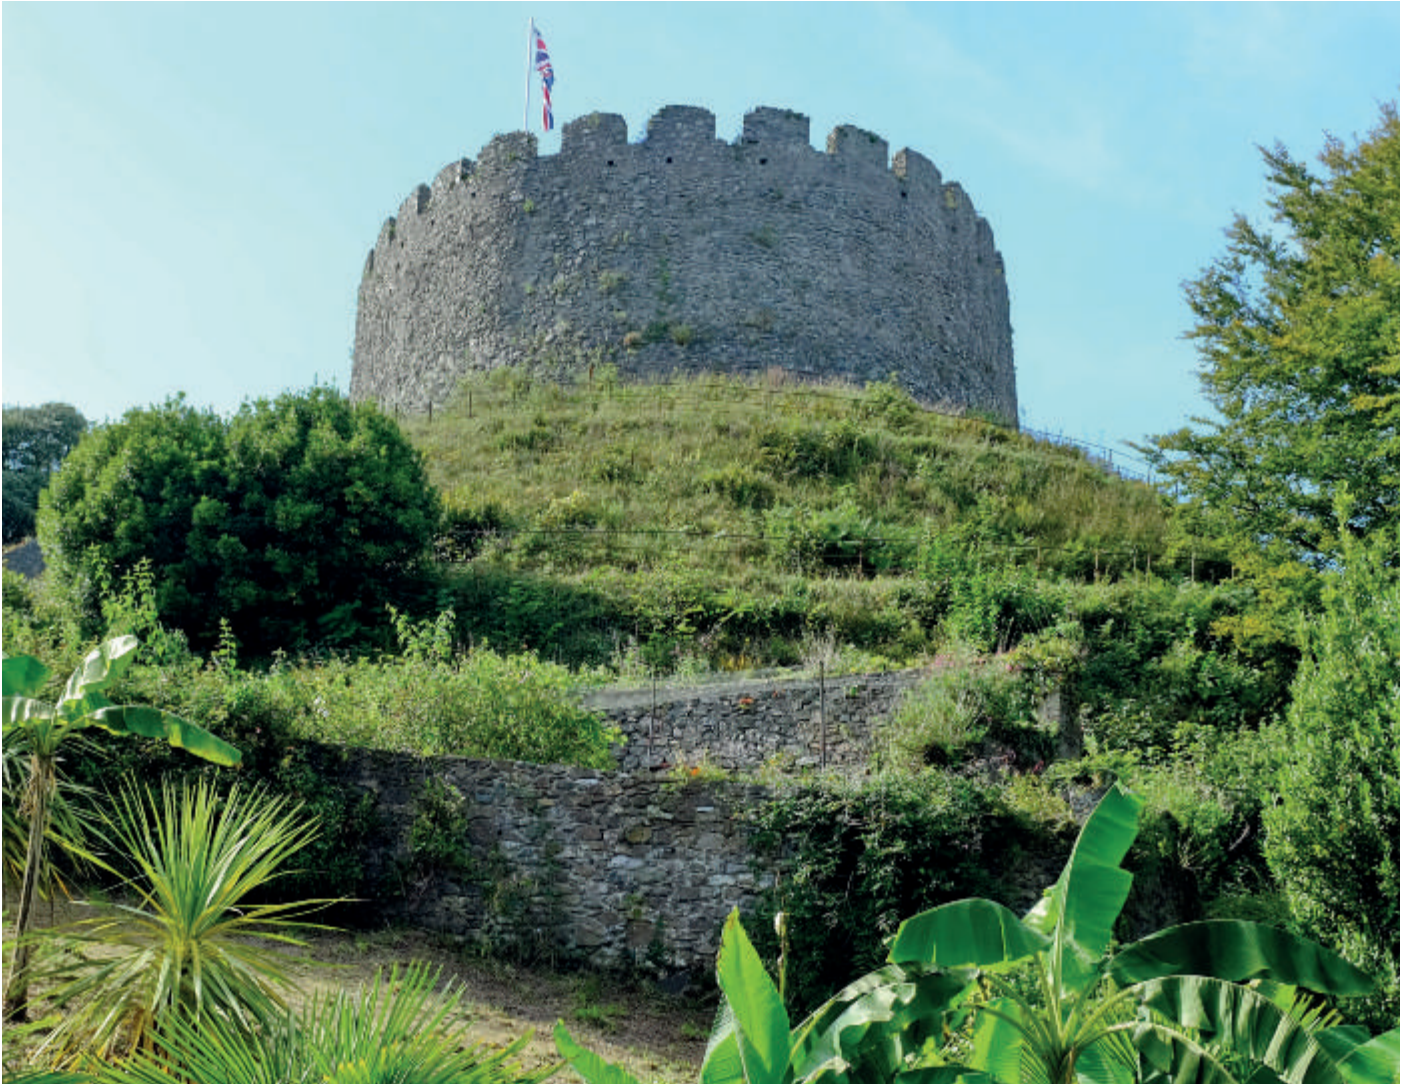
Fig. 1. Trematon Castle. The shell-keep from the south east (outside the bailey).

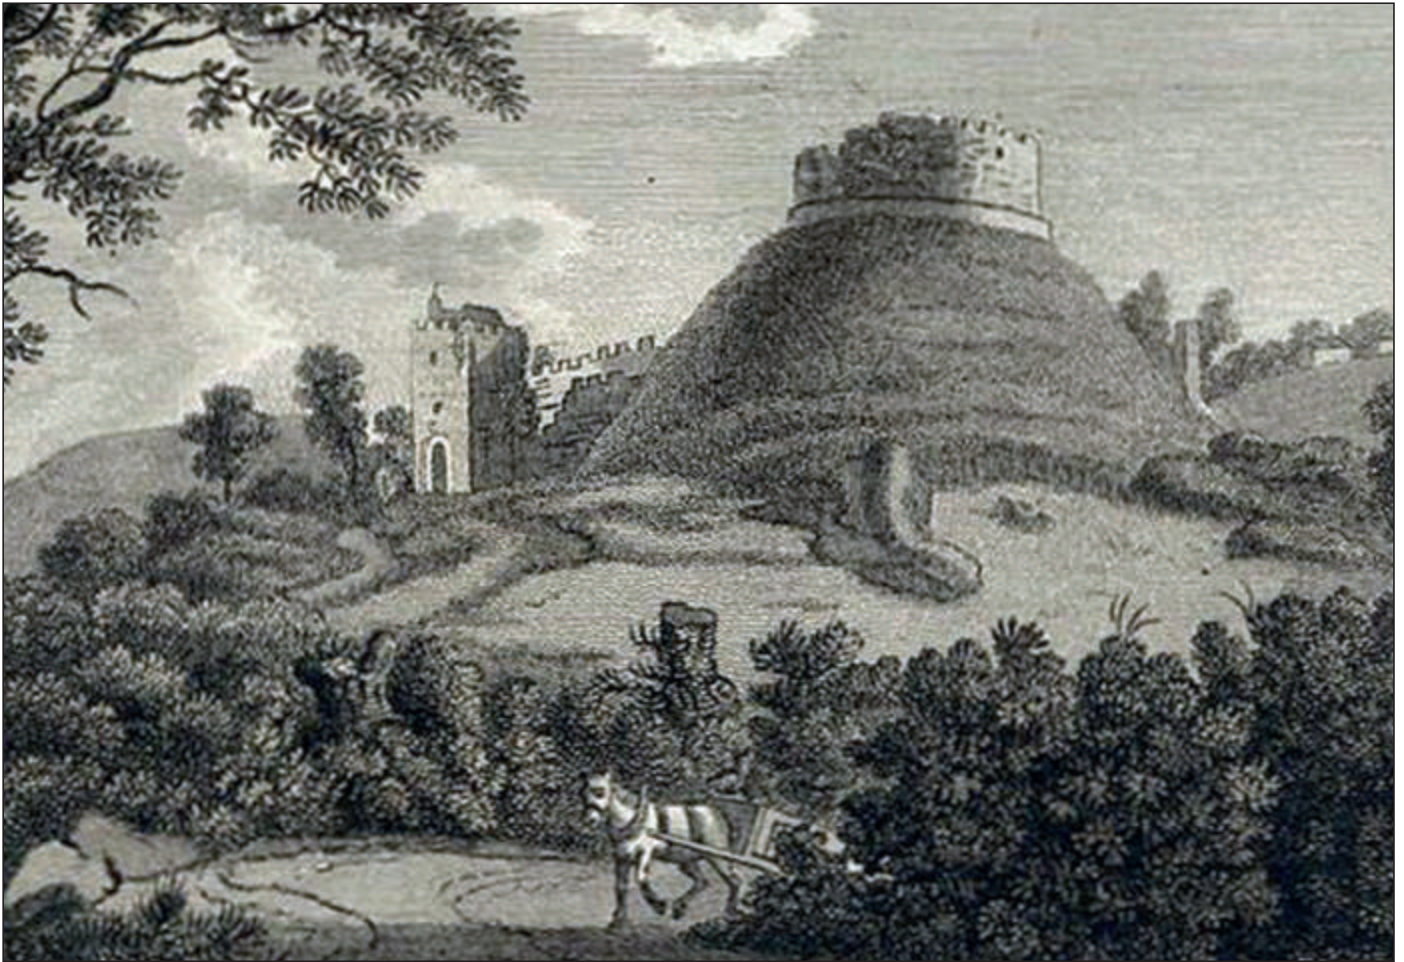
Fig. 2. Trematon Castle. Copper engraved print from Francis Grose's *Antiquities of England and Wales*, 1786. Vol. VIII, opp. p. 46. (Sparrow/Hooper). View from the north-east.

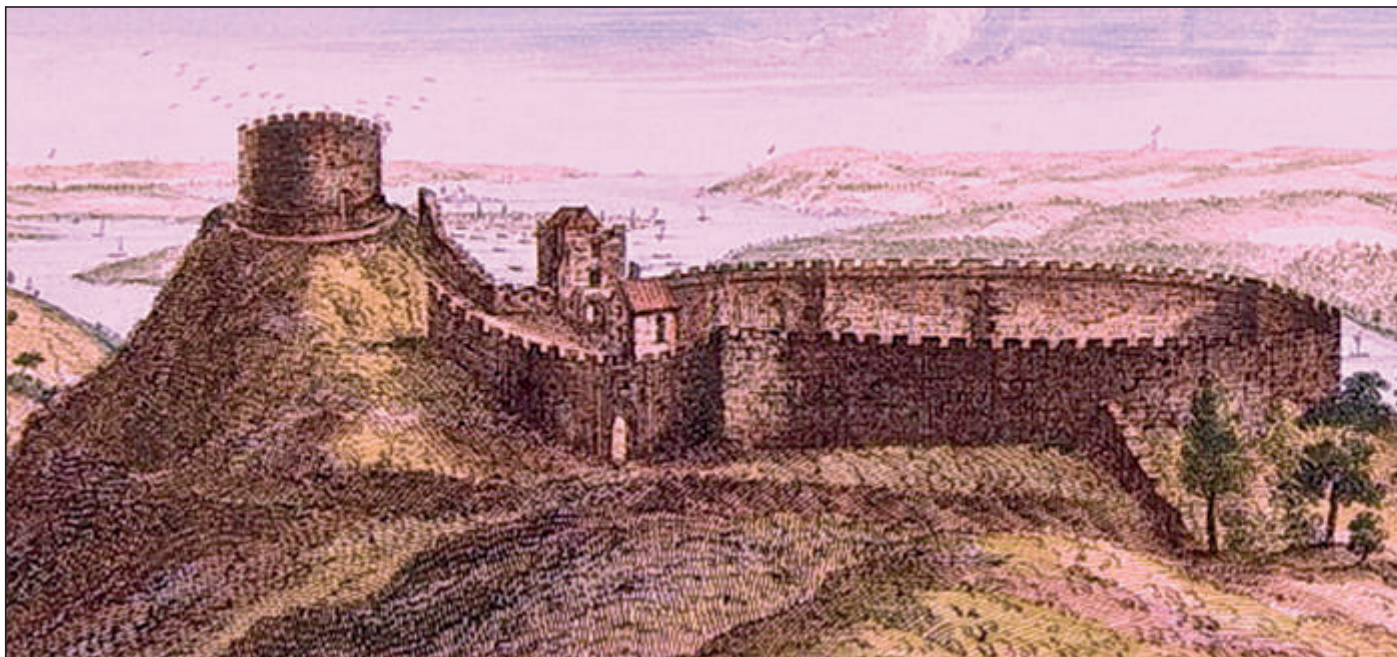
ABOVE: Fig. 4. Trematon Castle. S & N Buck, 1734. (Slightly cropped but much fuller detail than fig. 3). View from the west. Gatehouse on the east side, postern on the west and full extent of bailey. Note that in this view the wing walls do not fully extend up to the shell wall (unlike Toy, who made assumption that they once did).

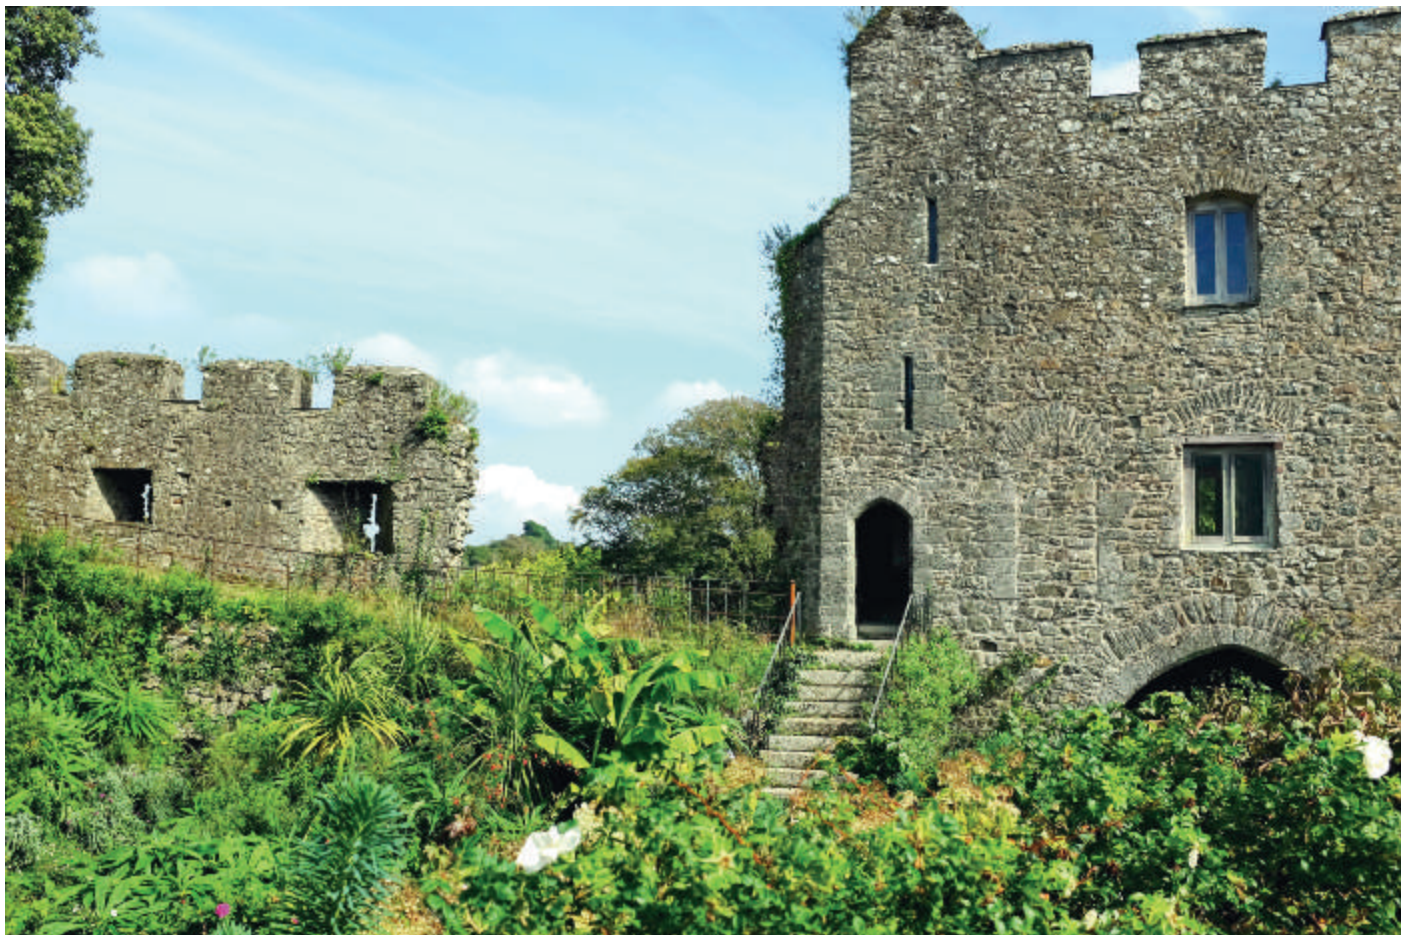
BELOW: Fig. 16. The north façade of the gatehouse looking down from the shell-keep outside and along the east line of the wing-wall. The gatehouse extends exclusively beyond the line of the curtain wall.

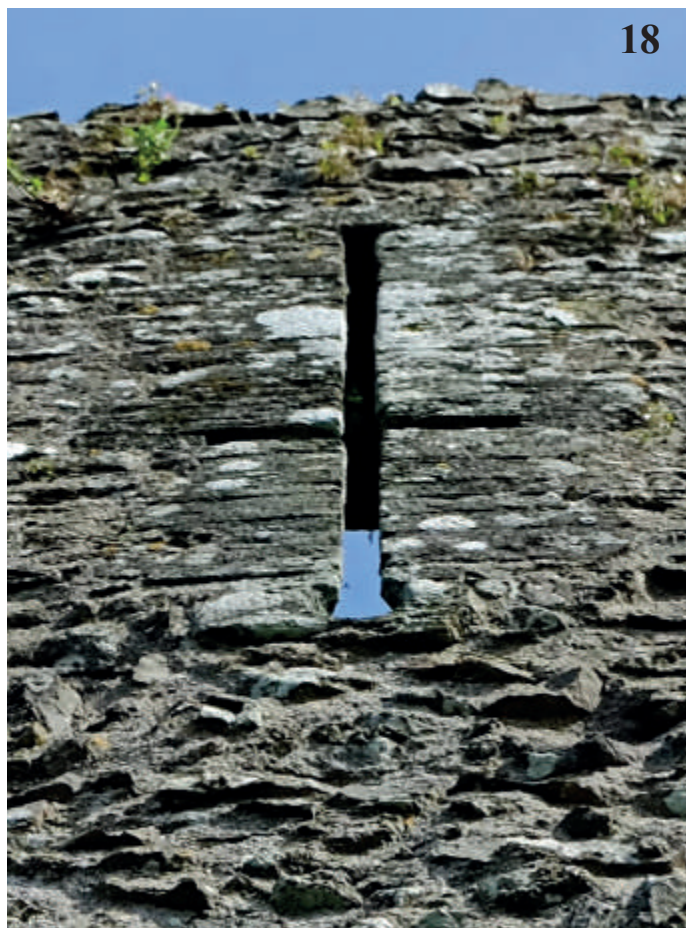
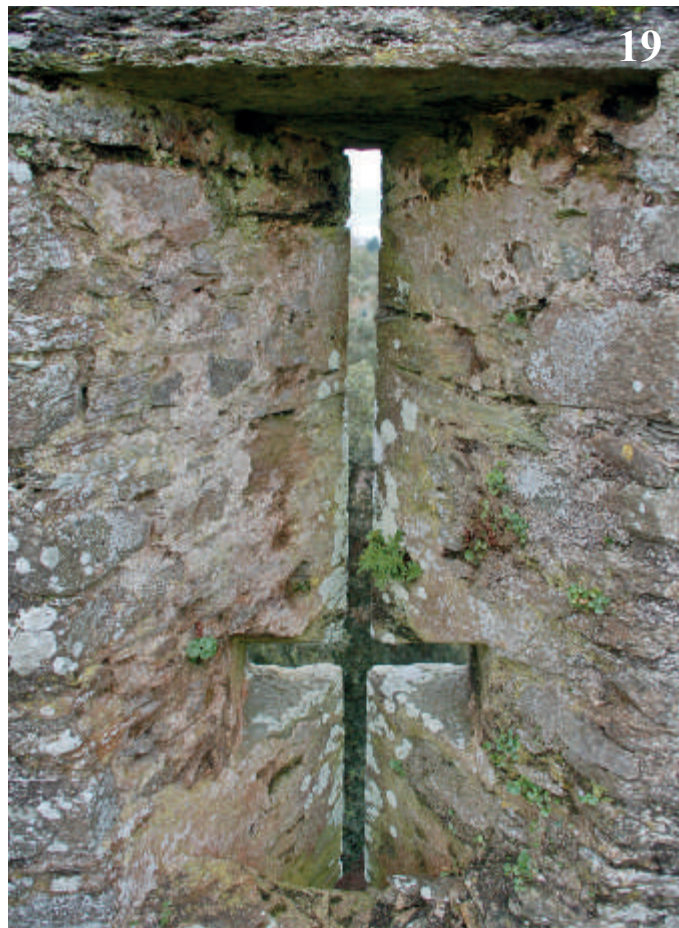
Trematon. Figs. 18-21. Clockwise. Left: 18: The sole remaining cruciform arrow slit along the shell-keep wall-walk from the exterior (see also fig. 10). Right: 19: Same loop from the interior of the shell-keep wall-walk.

The east wing-wall starts near the first-floor rear entrance of the gatehouse: perhaps a stair originally rose along the wing-wall from here? Since the (sole) arrow-loop in the shell-wall overlooks the bailey near the western wing-wall line, perhaps a stairway was originally protected by that wing-wall? In either or both cases, the path/stair must have turned abruptly at the summit to connect with the more centrally-placed doorway of the shell-keep. There are no scars where the wing-walls may have met the shell-keep. They must have been free-standing from the first, or possibly later additions.

But Renn suggests this loop survives from a rebuilding of the parapet and crenellations which removed others. Indeed, the top-most masonry of the whole shell may be a rebuild. There are indications of a change in masonry style and (externally) suggestions of some straight joints which may reflect an earlier and lower set of crenellations. The parapet and wall-walk is complete and carries a complete set of battlements. Below them (externally) is a continuous set of rectangular sockets indicating either timbers relating to the internal buildings or timbers supporting external defensive hours.

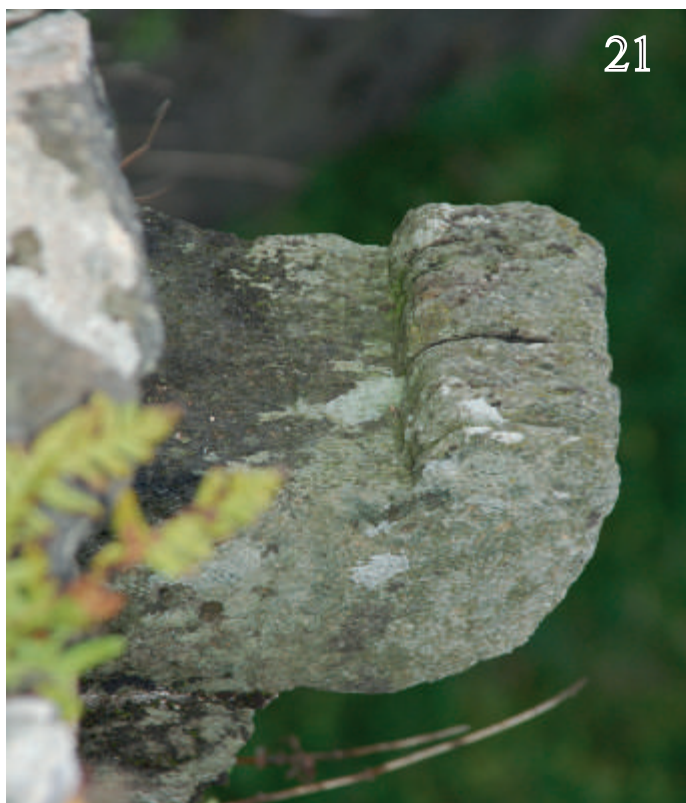
Below: Fig 20: Jambs /sidewalls within the entrance vault with modern lattice gate cutting through the chamfered impost. The vertical groove relates to a later door hanging. Fig. 21: One of the many indented grooved corbels that run around the interior (see fig. 12). Images 19-21 courtesy of Oliver Creighton.

The principal remains are the 13th-century gatehouse, the bailey curtain wall and the shell-keep on the large motte. Bailey and motte-top were formerly joined by ascending wing-walls. The doorway of the shell-keep faces the bailey but it is not now apparent how it was reached. The entrance is some 7ft (2.14m) wide, having a square-headed gateway (sockets for a former timber lintel) with a round-headed arch above, and a draw-bar. Secondary vertical grooves relate to a later door-hanging.

The shell-keep has a tall, sloping plinth to a shell wall some 25ft high. It is almost oval in plan, but the published plan (figs. 7, 11) (Toy 1933) is slightly misleading since on the northern side the shell-wall is largely straight, perhaps indicating that the main range of domestic building(s) stood against it. Its current austere emptiness creates a feeling of isolated and gloomy enclosure, but the presence of earlier buildings is indicated by a continuous (including the entrance area) series of corbels, with concave upper surfaces to accommodate beams (as at Restormel) which runs round the interior underneath the wall-walk (fig. 9).

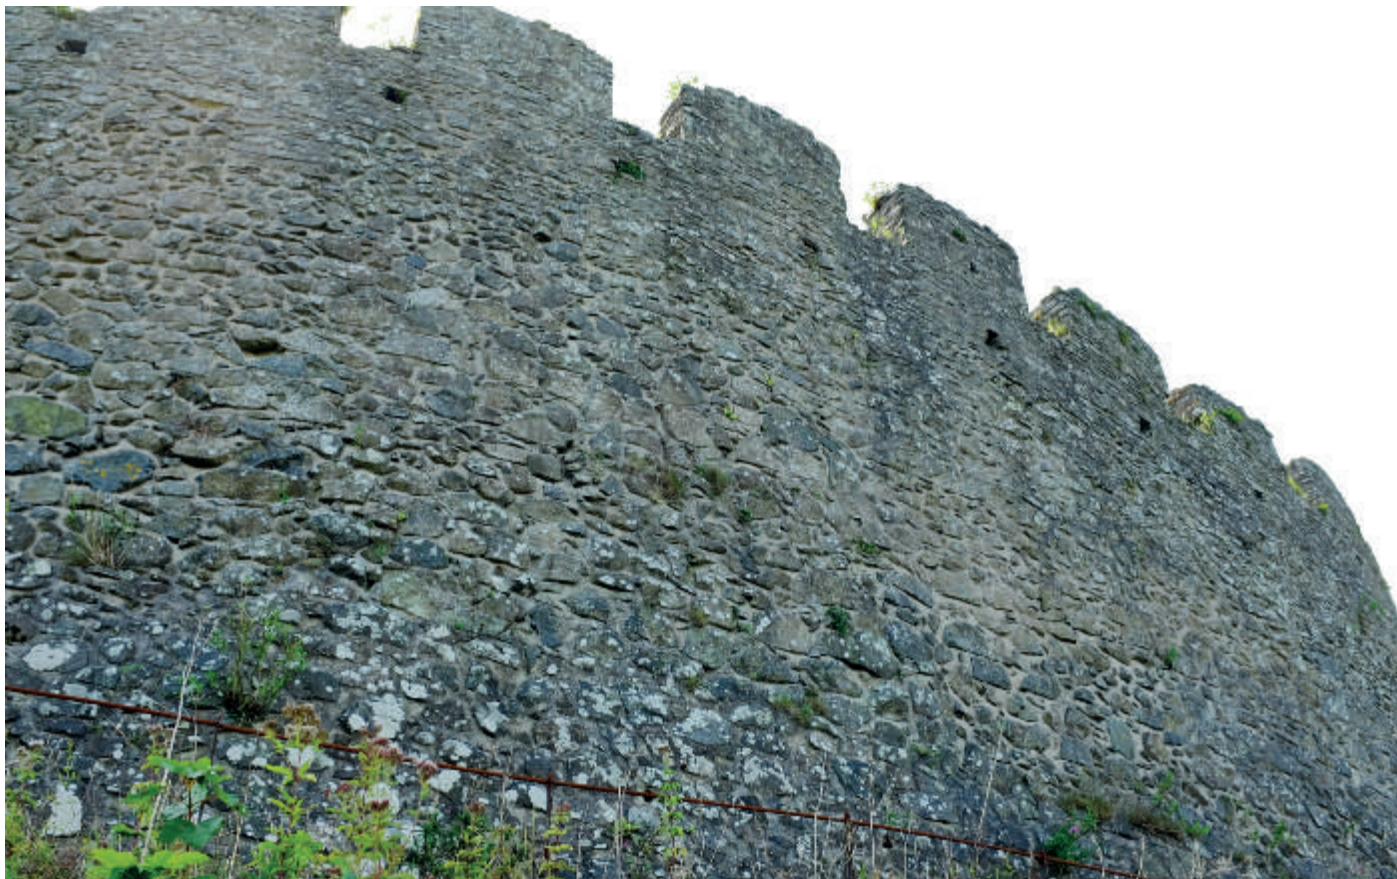
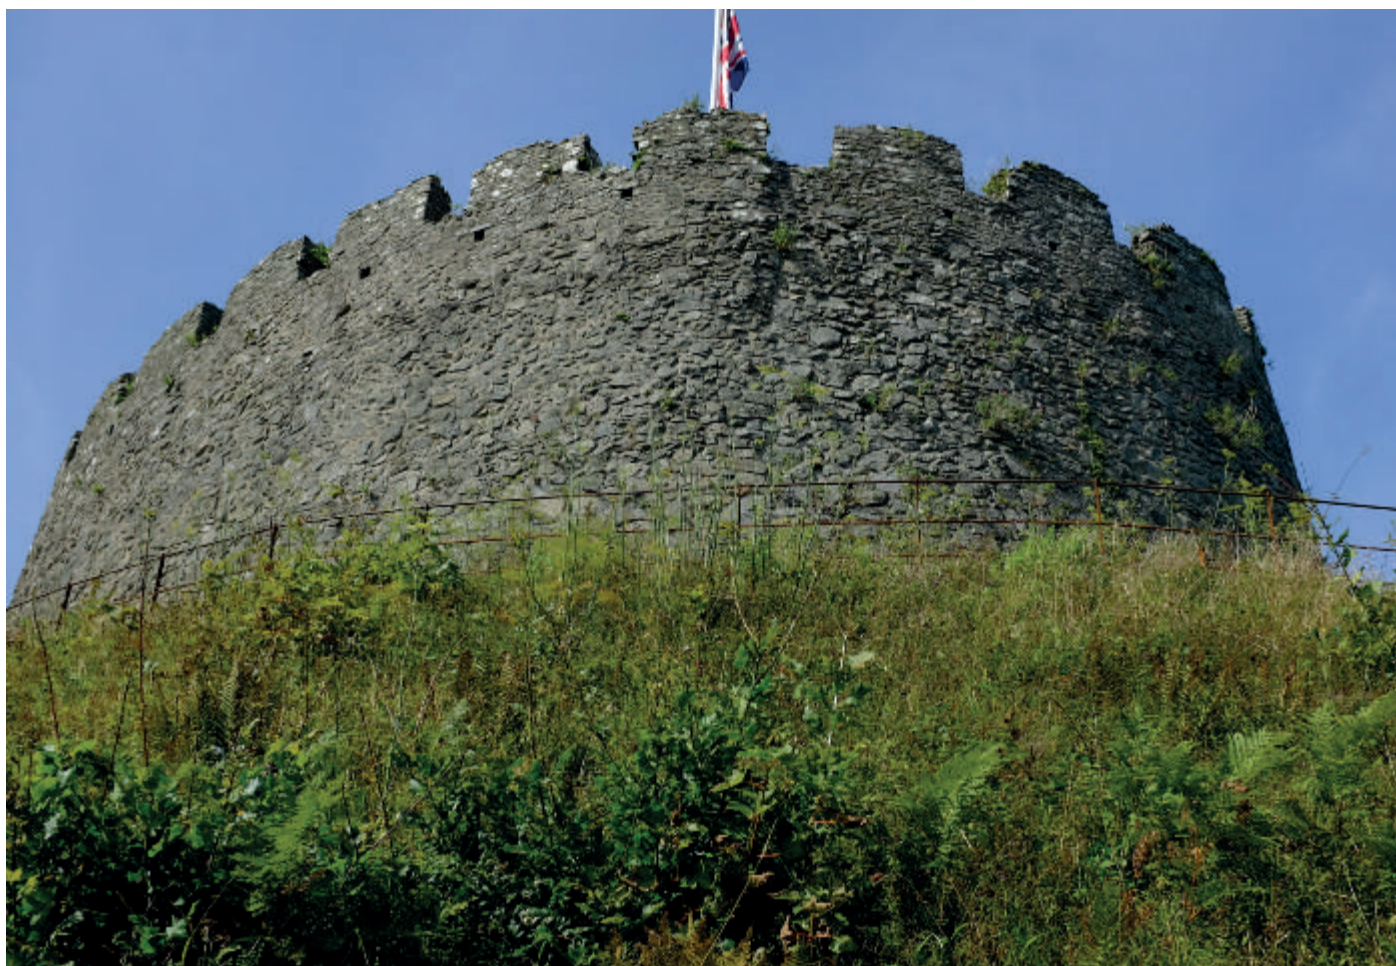
Fig. 22. ABOVE & Fig 23. BELOW: Views of the shell-keep exterior from the west (above) and east (below) showing surviving crenellations, beam sockets below to support a continuous line of timber hoarding and indications in the fabric of a heightening of the wall by some 10ft - all work of the late 13th century.

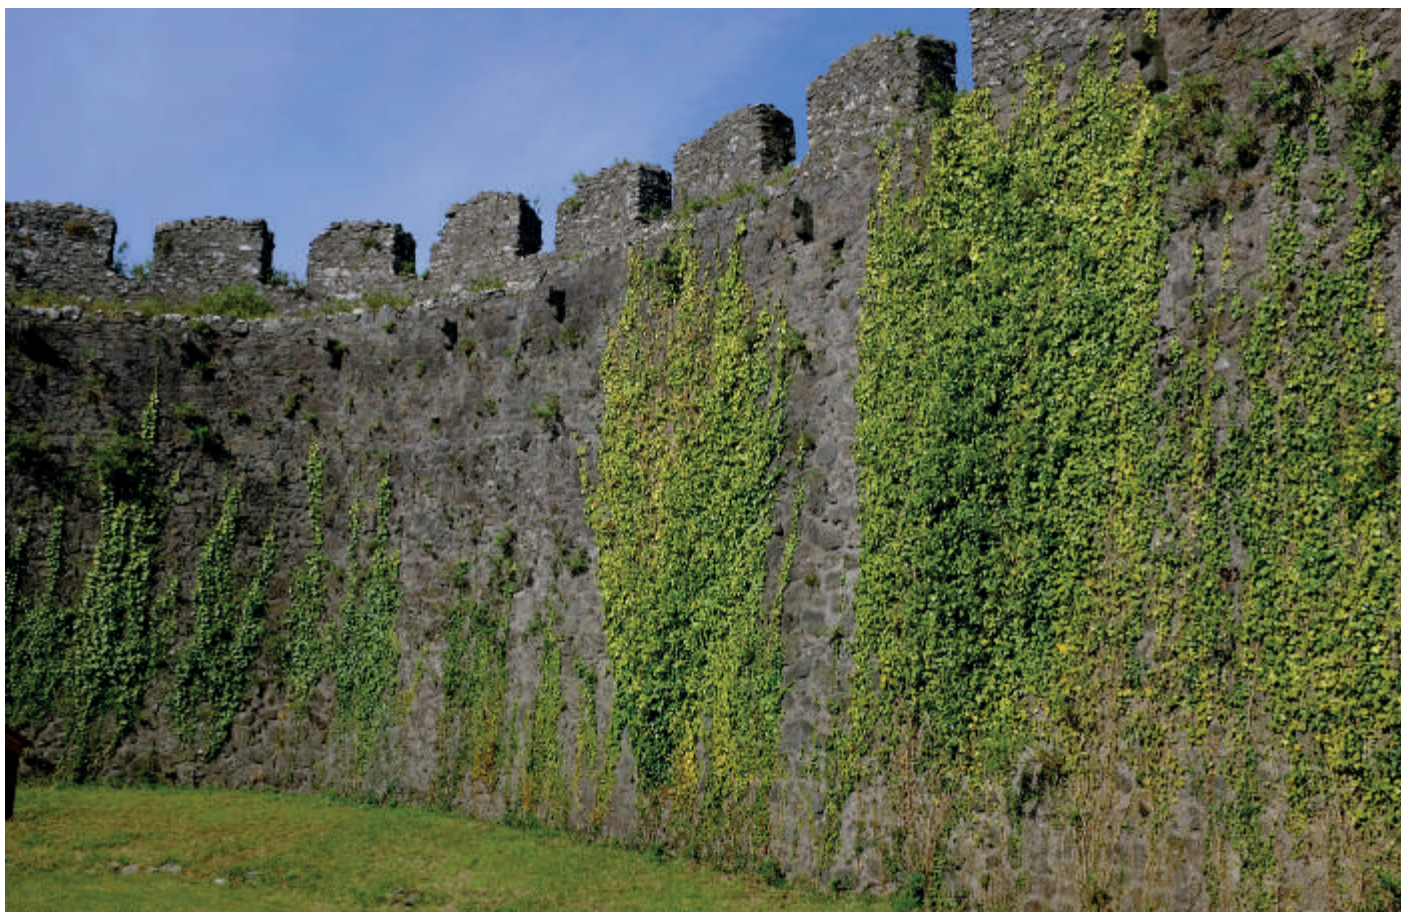
ABOVE: Fig. 24: View of the plain 25ft high shell-keep interior, looking north, showing surviving crenellations and the continuous row of corbels relating to former structures.

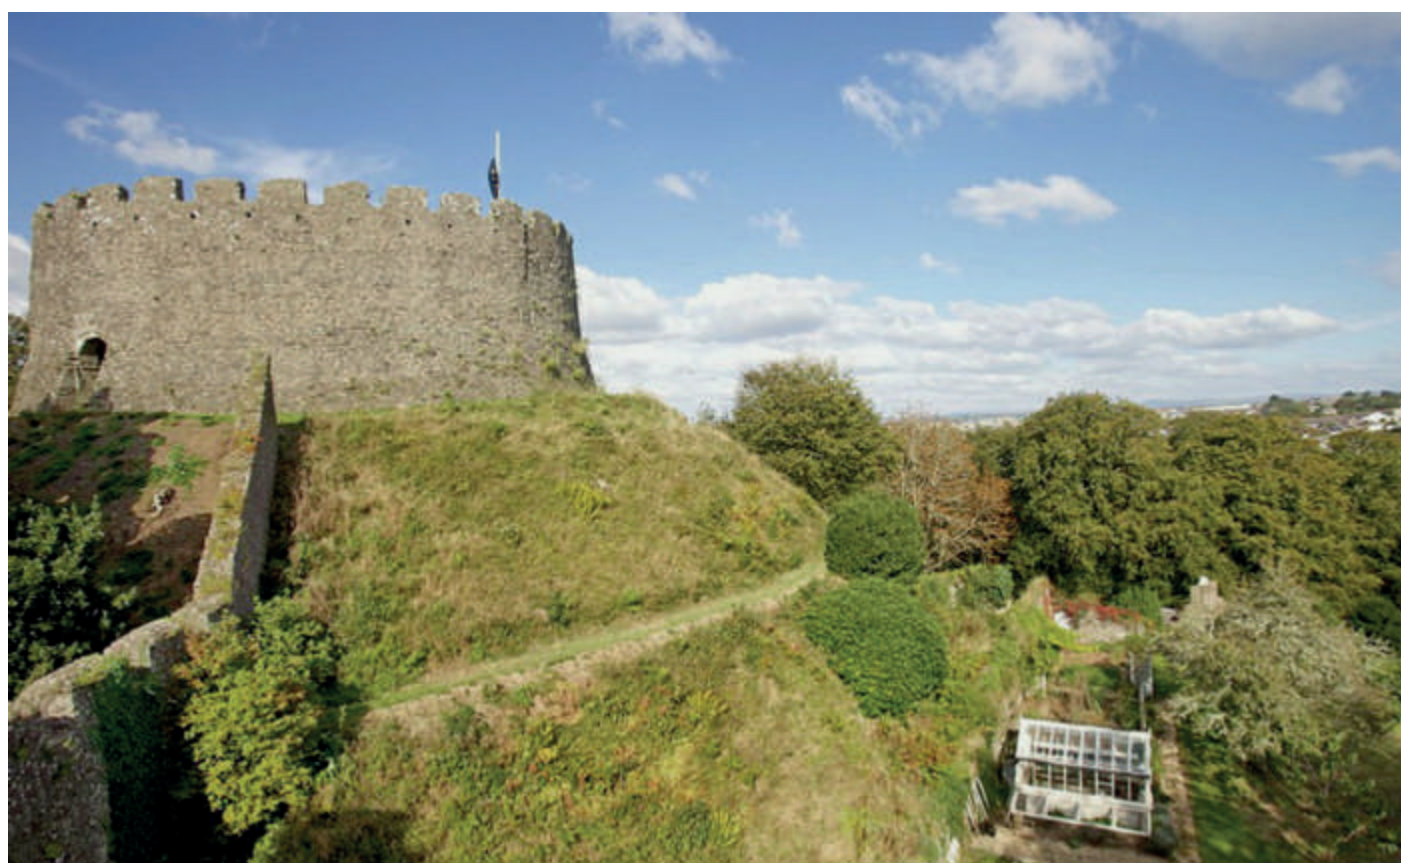
BELOW: Fig. 25: View from the gatehouse looking north toward the shell-keep. It highlights the distance between the east wing-wall and the shell-keep entrance.
