### **Red Bay Castle, County Antrim**

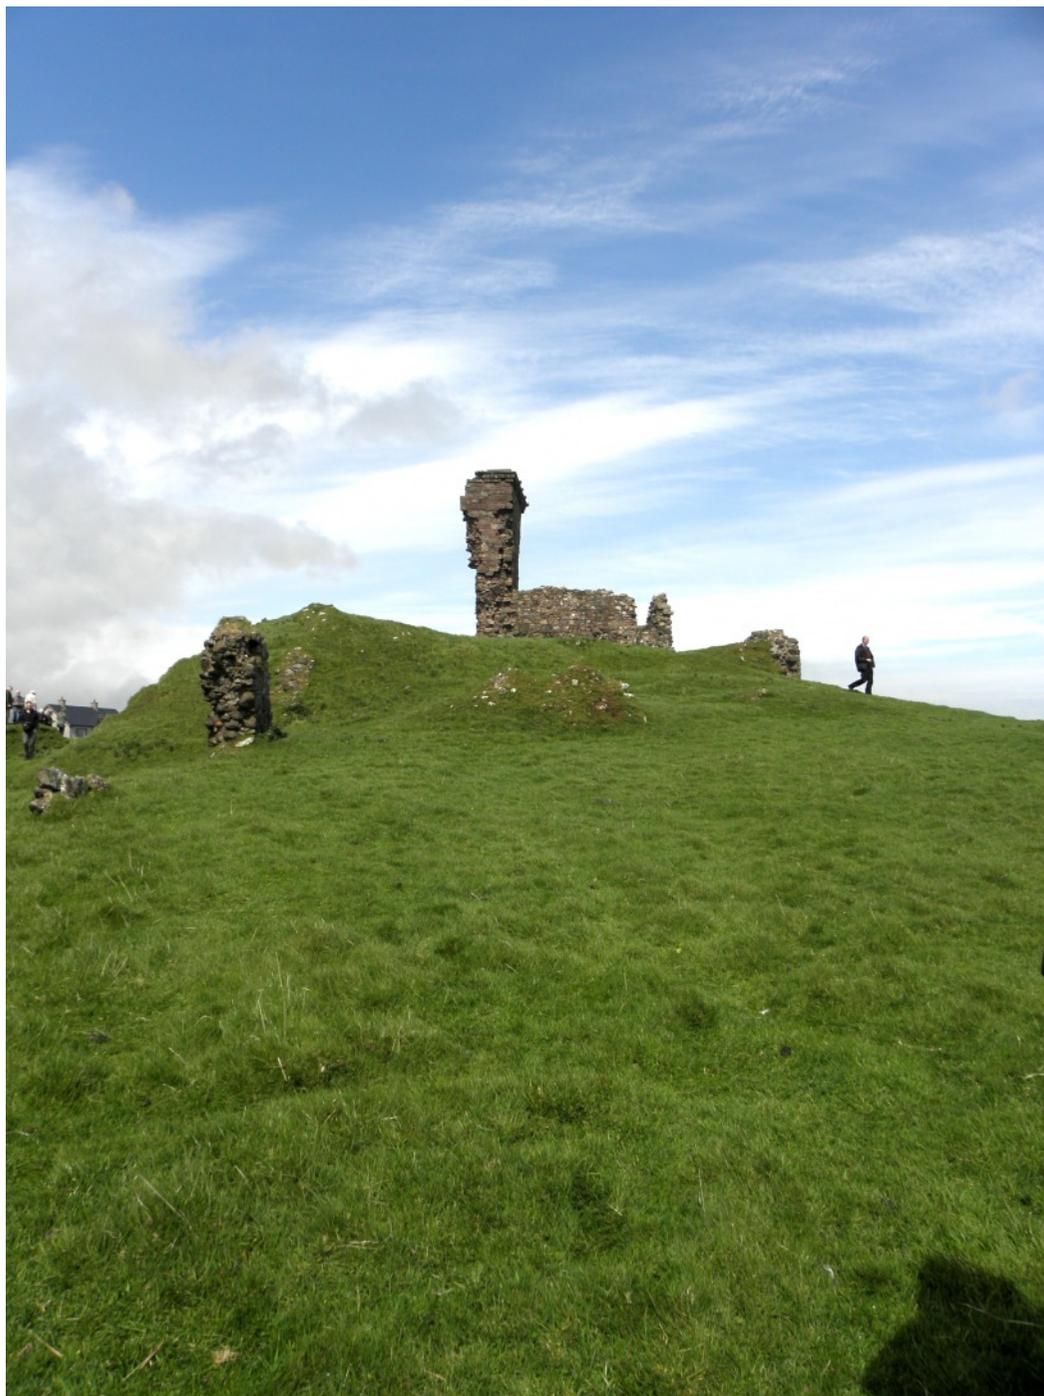
*Red Bay Castle. From the south. The fragmentary remains of a stone tower with Scottish mouldings, to the side of a bawn. It has been identified as part of the MacDonald castle; it is known from documents to have been here from 1563 or before.*

This is a difficult site to interpret. The only sure thing is that it has the remains of a stone tower with Scottish mouldings which can be identified as part of the MacDonald castle known from documents to have been here from 1563 at least. A wall along the cliff edge abuts this tower. The tower is now situated on the top of a mound which runs down into a ditch which in turn runs along the north and west sides of the mound and then merges with a natural gully. From the west this combination looks like an earlier motte (the mound) with the ditch enclosing a bailey. However, there is no sign of a ditch along the south-eastern side of the

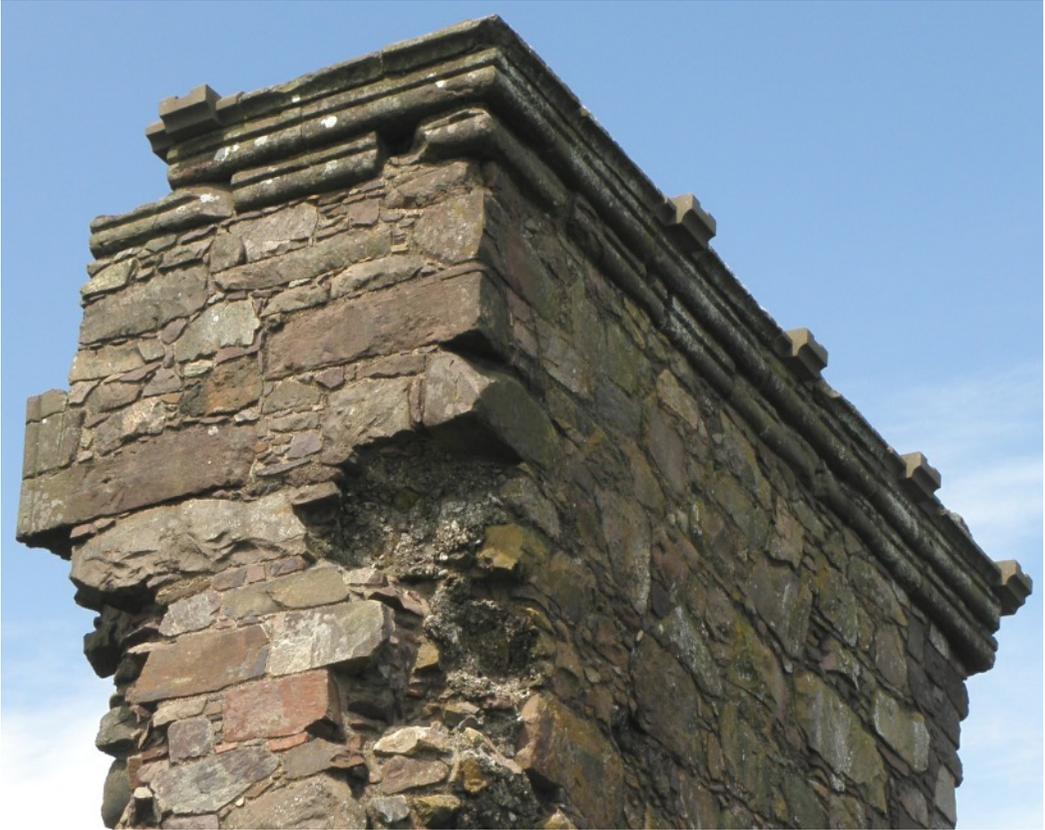
*Red Bay Castle. The part-remains of the stone tower with Scottish, late 16th or early 17th century Renaissance mouldings. The odd corbels (part rain water spouts?) along the cornice are imaginative modern recreations and may or may not have replaced originals. There is also a hint of a window jamb with roll mouldings on the west side.*

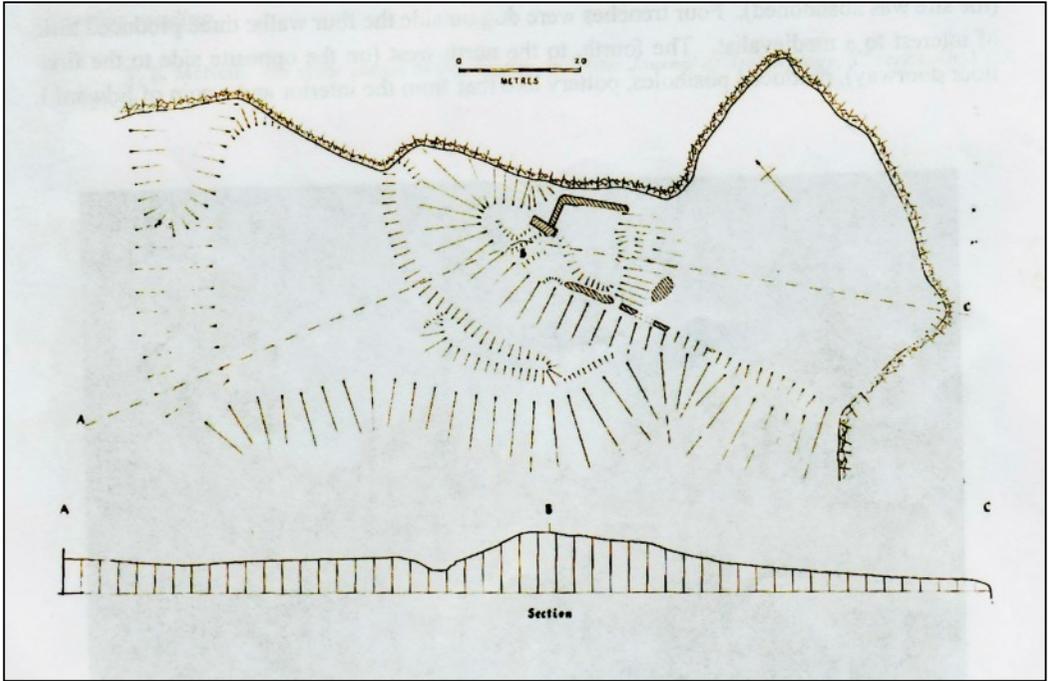
*Red Bay Castle. Looking north over the ditch, with mound to the right, towards Cushendall.*

mound, separating it from the "bailey" and from the east the mound looks, not like a motte, but a pile of debris from the collapse of the tower. Further to the west, there appears to be a shallow ditch running from the cliff to the gully and cutting off the promontory. This could be either the remains of a promontory defence or simply a natural drainage feature, especially on the north. The site needs a systematic geophysical survey or excavation.
