## **Cowdray House**

#### Cowdray House - Midhurst.

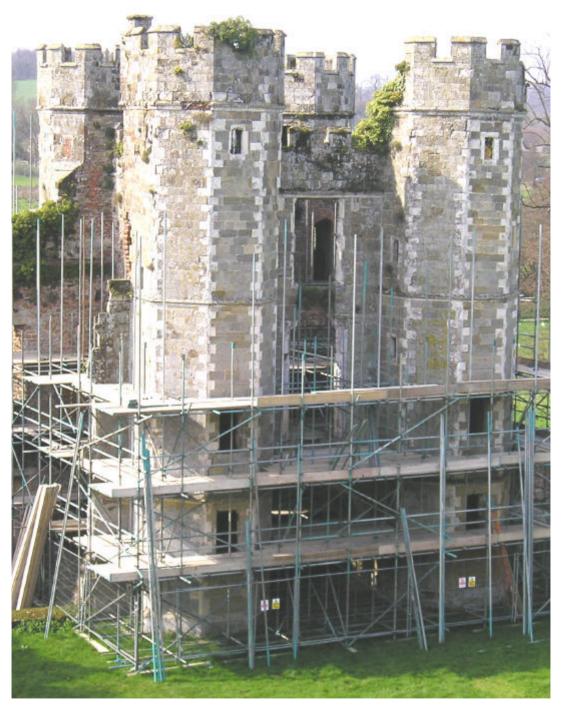
**Cowdray House.** The Gatehouse from the courtyard. For over 200 years the shattered remains of the once magnificent Cowdray House have seemed empty and lost, mouldering away in ivy-clad ruination. Now, the Heritage Lottery Fund and the Cowdray Heritage Trust are investing £2.7 million to keep it as a romantic ruin. It currently offers a striking contrast to many other properties in care should not be missed.

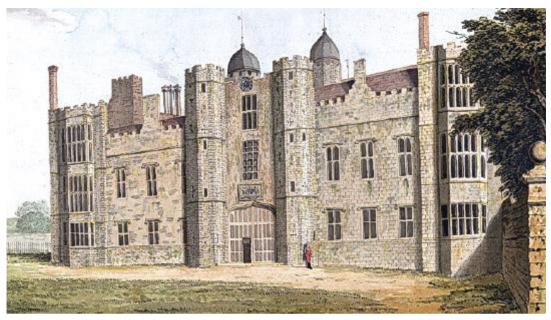
Fig 1. Cowdray House - The west, entrance façade, completed in its entirety by 1545. The Gatehouse was constructed in the late 1530's, of rubble faced with ashlar with white stone quoins. It is of three storeys but has lost its floors and roof. From a watercolour of the 1780's by S H Grimm. BL Shelfmark: Additional MS 5675, f. 11 (no. 17). All the Grimm paintings in this article are reproduced by kind permission of the British Library.

If you arrived at Cowdray in the early 1780's, during the time of the seventh Viscount Montague, you would have entered through the great double door of the **Gatehouse (Fig 1)**. The imposing gun-looped gatehouse was three storeys high, with an octagonal turret at each of its four corners. Above the entrance arch are the coat of arms of Anthony Browne, first Viscount Montague and at the very top, just below the embattled parapet, there was a single handed clock, another face of which was on the court side

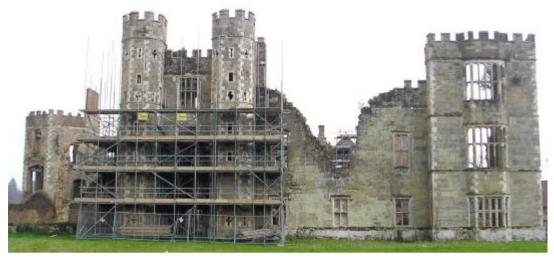
**Fig 3 Cowdray House**. The west, gatehouse facade. Gatehouse circa 1535-40 with alternating nominal gun loops and decorative arrow slits. The canted bay windows in the NW and SW corner towers were probably later. The Heritage Lottery Fund have recently agreed to a £2.7 million campaign of conservation and the consolidation of the Gatehouse is the first phase of this work.

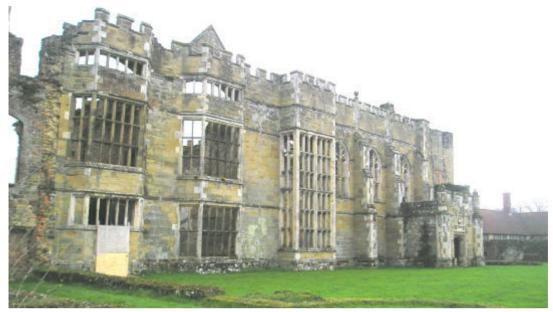
**Fig 6. Cowdray House.** The East Range. To the left of the rectangular oriel window of the Hall are the Elizabethan canted bays to the Parlour & Great Chamber and vaulted cellar (access currently boarded acting as a temporary door) and above, the Dressing Room.

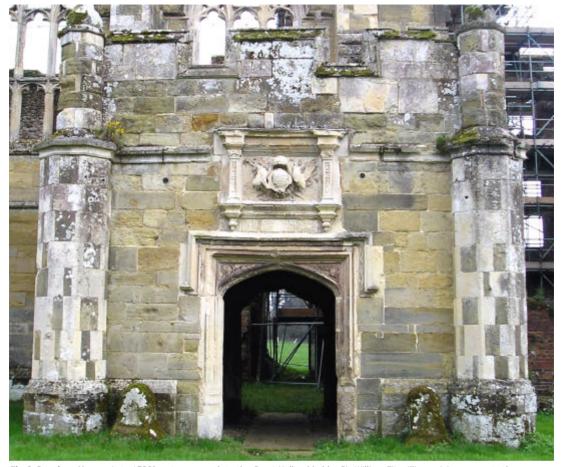
**Fig 9 Cowdray House.** Late 1530's entrance porch to the Great Hall, added by Sir William Fitzwilliam, giving access to the screens passage, with the hall to the left. The Great Hall has three perpendicular windows, high up, each of three lights with cusped heads and a transom. The motif of the alternate white and dark- polychrome - ashlar is carried forward from the gatehouse into the mini turrets

Inside, the **porch** is nearly square and the floor was paved with marble slabs. Above is an intricately carved low-relief stone fan-vaulted ceiling. In the centre is a rose with a crown and around this are eight cusped quatrefoils. In the corners the fans are each divided into four sections (**Fig 8**), in which alternate a large anchor and a trefoil bearing the letters, W.S., referring to the builder, William, Earl of Southampton. The anchor alludes to the Earl of Southampton as the Lord High Admiral of England. Also, among the spandrels of the south-west corner fan, there are four heads, two appear to be cherubim, while the

The porch is one of the best preserved portions of the house. The marble floor has gone, as has the plaster on the walls, but the carved ceiling is nearly fully intact and the carving still very crisp. The exterior of the porch also remains reasonably well preserved, except for the Royal coat of arms, which has either worn or been badly mutilated, but is 'one of the few mean touches in the whole building' - Pevsner.

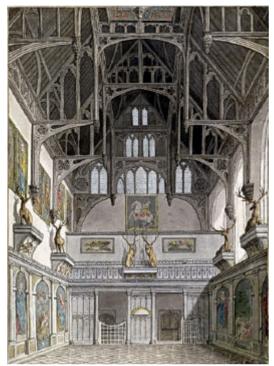
**Fig 10 Cowdray House** - Buck Hall, c 1780, showing the Buck motifs of Sir Anthony Browne. Looking south toward the screens passage. Watercolour, Shelfmark: Additional MS 5675, f. 14 (no. 20)

openings. In the southern gable (Fig **10**) were a group of traceried windows. designed correspond with the openin inas the In roof. the second bav from the north, was the louvre open (Fig 11) that nominally received the smoke from

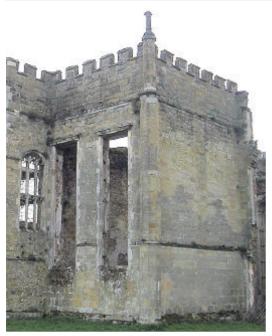
**Fig 12 Cowdray House.** The stairwell block adjacent to the Chapel that houses the stairway to the first floor apartments. There had been long windows in the north wall (now blank) blocked in the early eighteenth century to accommodate the Pellegrini paintings.

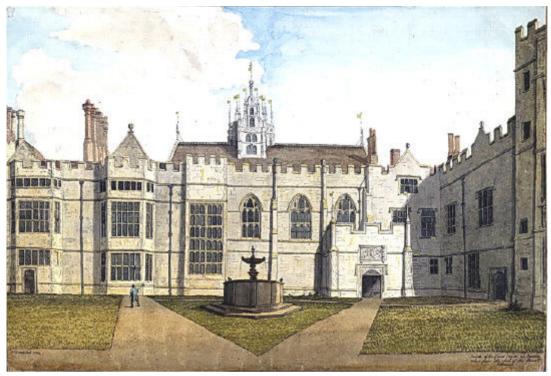
**Fig 14. Top.** Samuel Hieronymus Grimm, 1782: Watercolour: A view of the inside of the great court at Cowdray taken from the arch of the great entrance' in (West) Sussex. British Library Ref: Additional MS 5675, f. 12 (no. 18).

Fig 11 Cowdray House - The louvre of the Great Hall, perhaps by Anthony Browne, 1540's . Two storeys in height. A detail of the S H Grim watercolour (Fig 14).

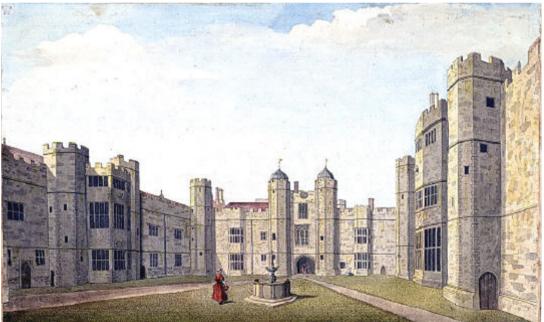
**Fig 15. Below.** Samuel Hieronymus Grimm, 1780-1791, Watercolour, A watercolour view of the west side of the great court, looking toward the Gatehouse, at Cowdray in (West) Sussex. British Library Ref: Additional MS 5675, f. 13 (no. 19).

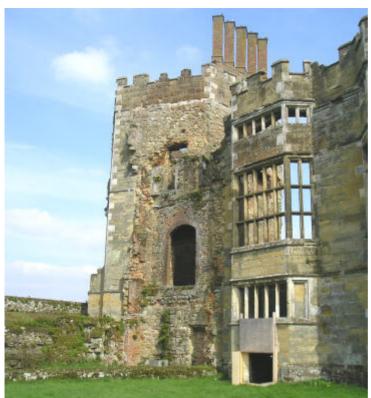
**Fig 21 Cowdray House.** The hexagonal north-east strong tower containing the bedchambers of the Earl, with access to the first floor of the north range. The phalanx of chimneys highlights that this north-east corner of the house is high status. Although the tower is hexagonal, it is not a visual companion piece to the kitchen tower in the SE.

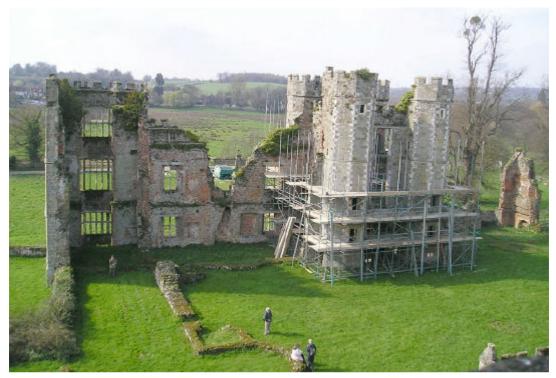
**Fig 22 Cowdray House.** To the left is the demolished **south range**. Centre right the west range gatehouse. The south range originally contained a long gallery at first floor level, to mirror that on the north range. It was later altered into accommodation units.

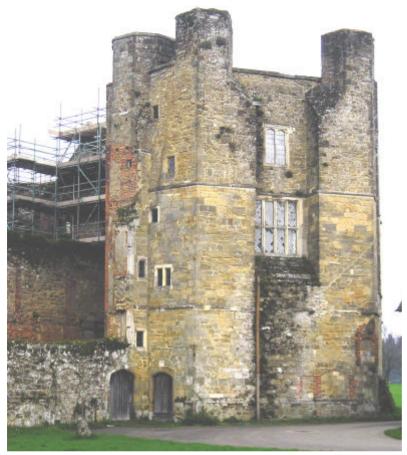
**Fig 23. Cowdray House. The Kitchen Tower**. A far more solid castle-like affair than any of the other towers or blocks. The other buildings seem flimsy by comparison. There are some similarities to the hexagonal Kitchen Tower at Raglan.

In the southeast corner of Cowdray is the massive hexagonal **kitchen tower**. It is the only tower that feels castle-like in its substantiality, and could have been copied from the hexagonal vaulted Kitchen Tower at Raglan. internal diameter is 26 ft or 30 ft from corner to corner and because it was so substantial it was the only part of the house that did not get badly damaged in the fire. The kitchen is on the ground floor and within the four massive arches along its south and east sides are the fireplaces. Two of these are of special interest. The northeast is filled with a large hot plate with two rows of round holes for saucepans and dishes, which was heated by two fires beneath. Behind the hot plate is a window giving light to the working area. In the flue of the eastern arch are the original spit wheels and fans that used to be turned automatically by the rising heat, like that in the kitchen of the Royal Pavilion, Brighton. The iron range and hole in the floor for the basting pan also remain. On the north side of the kitchen, the old serving hatches have also been blocked up. The kitchen was lighted by a lantern-like series of four large seventeenth century windows, places high up. Some still retain fragments of their original glass.

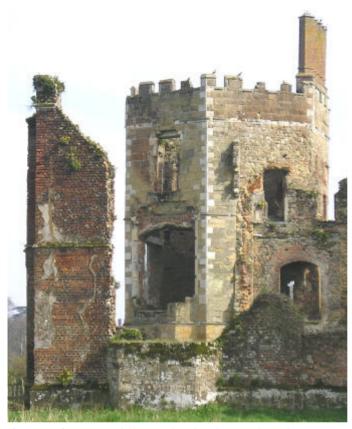
**Fig 24. Cowdray House.** The hexagonal residential tower in the north-east corner, with its fashionable pattern of interlocking brown and white quoins. The huge bay window is probably a later Elizabethan enlargement.
