Fig. 1. Tretower shell-keep & donjon. View from the north-west. The shell-keep is dated to the mid-to-late 12th century and the central tower an addition of c. 1230-50, when other internal buildings were gutted.

17. Tretower

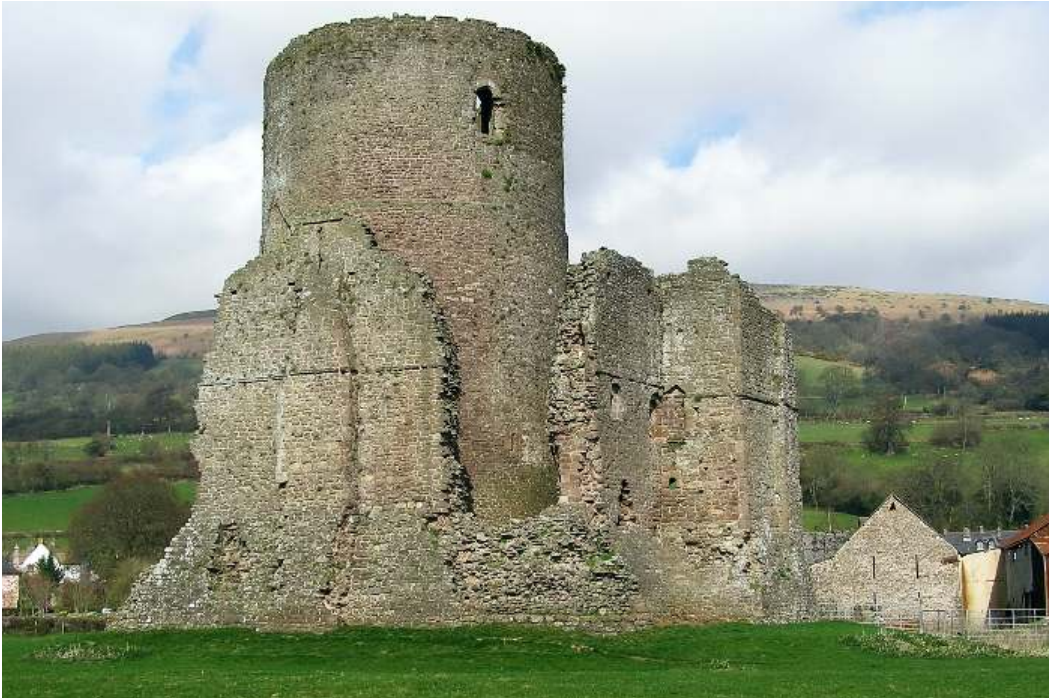
Fig. 2. The shell-keep from the south-west. The missing corner (it fell as late as 1947) is the section that contained the spiral staircase. Hall to the right (two blocked windows), with the kitchen & fireplace dog-legged out, and solar to the left. The solar has a blocked window to the right of the chimney stack at first floor level.

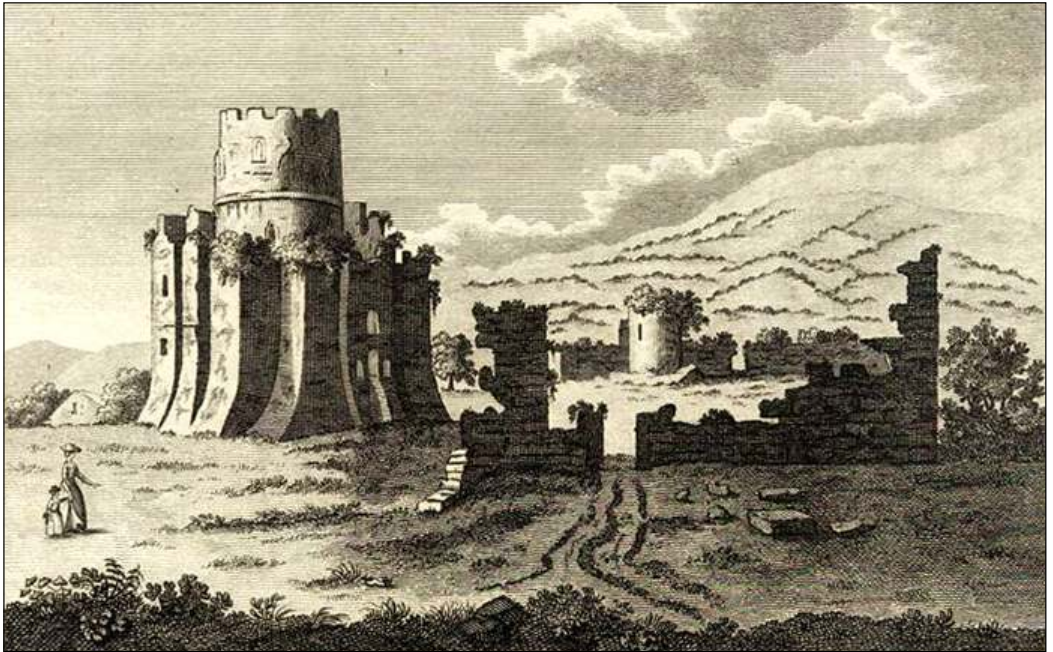
ABOVE: Fig. 3. 'Trtior Castle in Brecknockshire', copperplate published by Alexander Hogg, c. 1780s. Engraving is based on an original illustration by Samuel and Nathaniel Buck (1741)(fig. 5). Gatehouse tower stands nearly to full height.

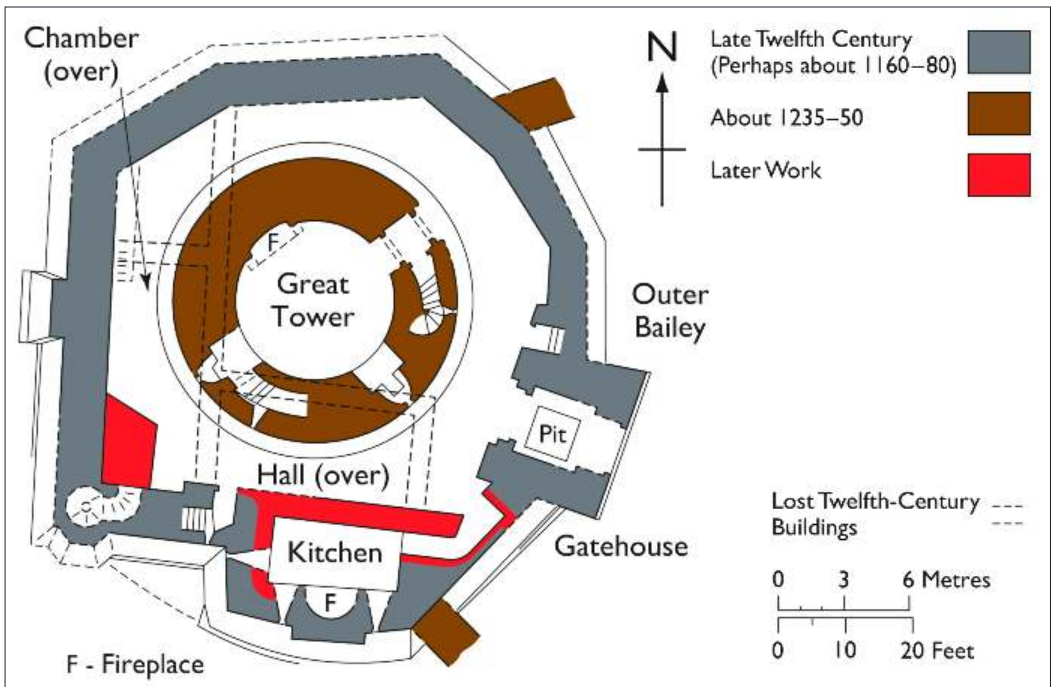
BELOW: Fig. 4. Most recent ground plan from Cadw. © Crown Copyright (2015) Cadw. See also fig. 8.

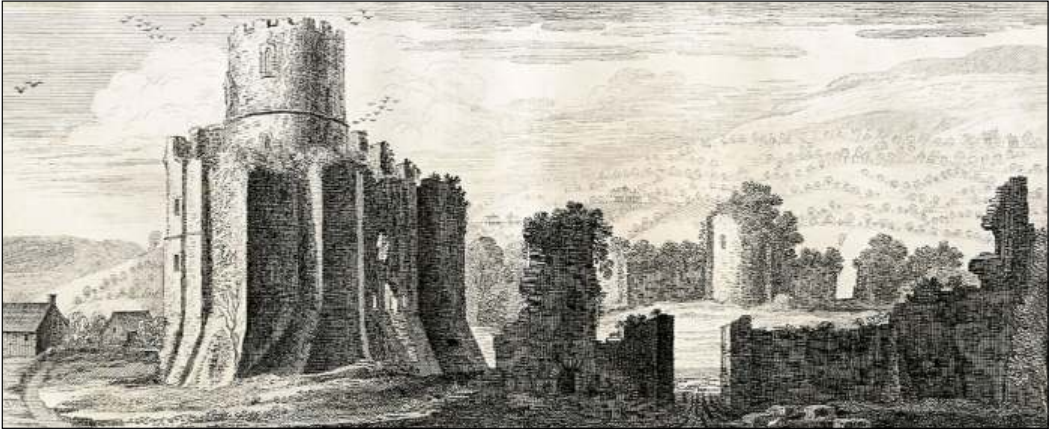
ABOVE: Fig. 5. Samuel & Nathaniel's view of Tretower Castle from the south (1741). The mid-12th century two/three storey gatehouse remains intact.

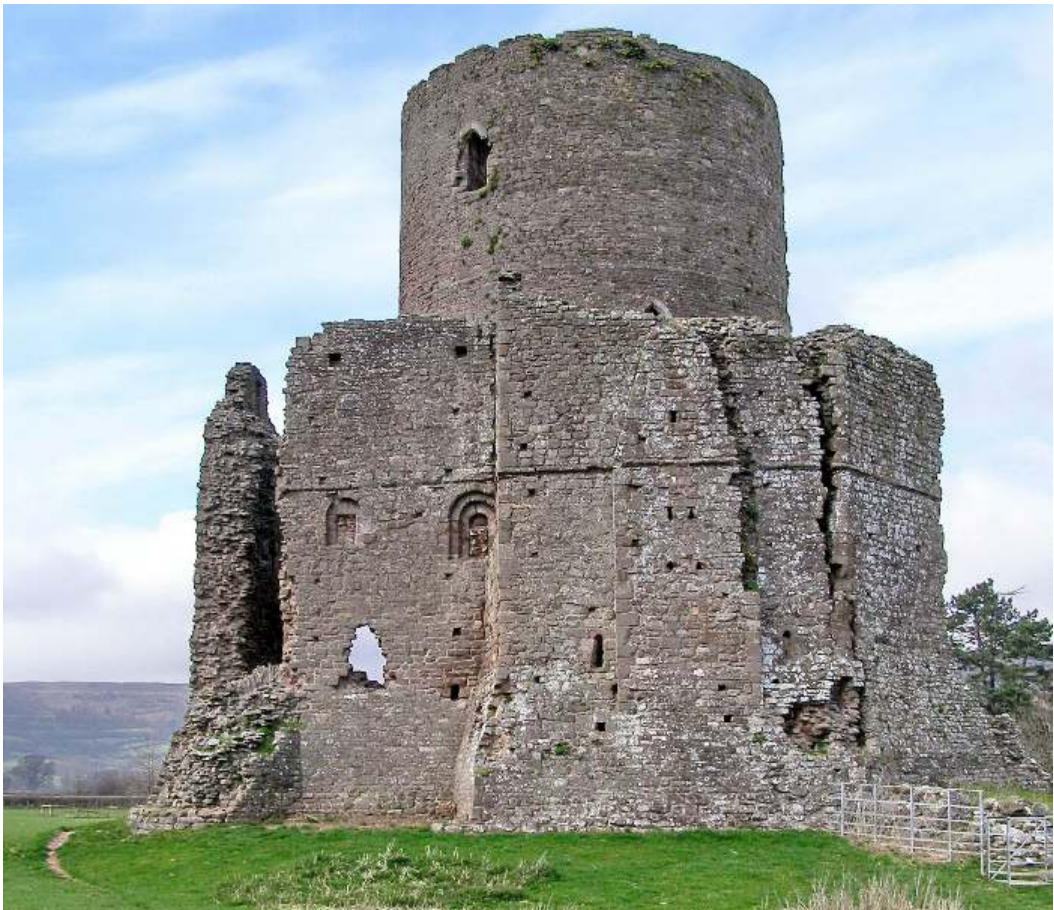
BELOW: Fig. 6. The shell-keep section with the hall (blocked windows) and the flue for the kitchen fireplace, with triangular and rectangular smoke vents (cf. Ogmere).

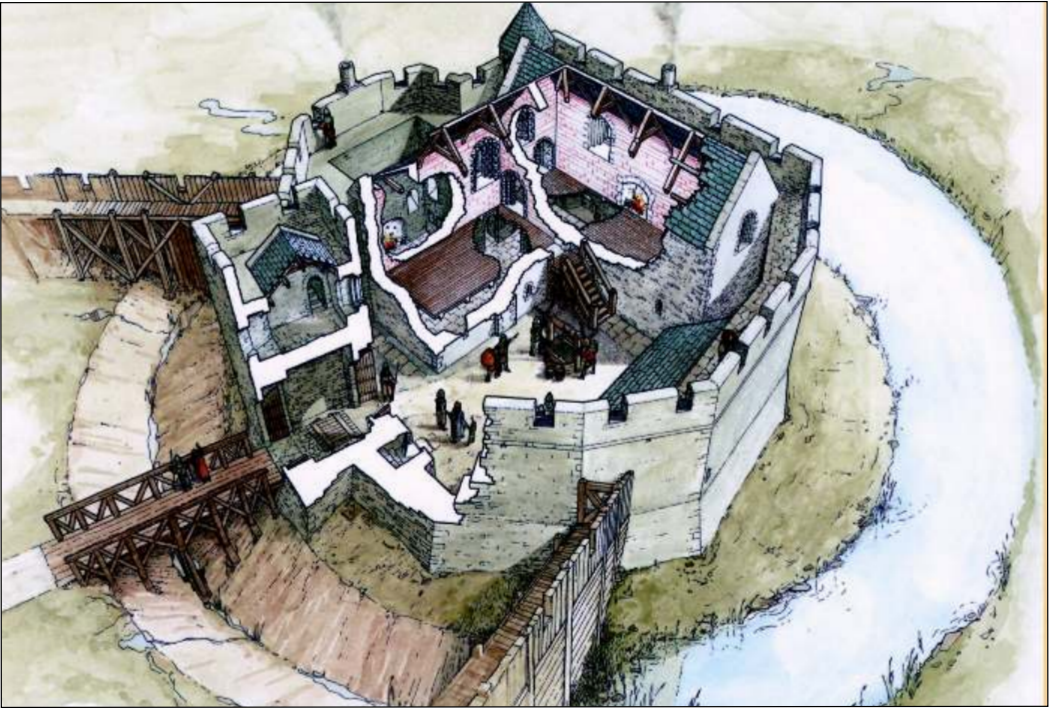
ABOVE: Fig. 7. A cut-away reconstruction of the shell keep as it may have appeared in the late 12th century. The chamber (or solar) with fireplace is to the right; the hall to the left, accessed, presumably by a wooden stair from the courtyard. (Illustration by Chris Jones-Jenkins). From Robinson (Cadw), 2010. Reproduced by kind permission of the illustrator.

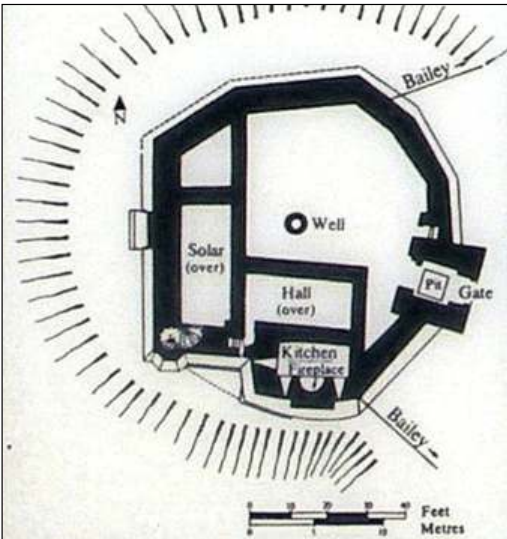
BELOW: Left: Fig. 8. The plan of the shell keep prior to the building of the round tower (Photo of the Cadw on-site information panel. Crown copyright. (2015) Cadw. Right: Fig. 9. Detail of the solar on the west with a 13th-century displaced-traversed arrow slit at the crown of the chimney stack and wall-walk (cf. White Castle).

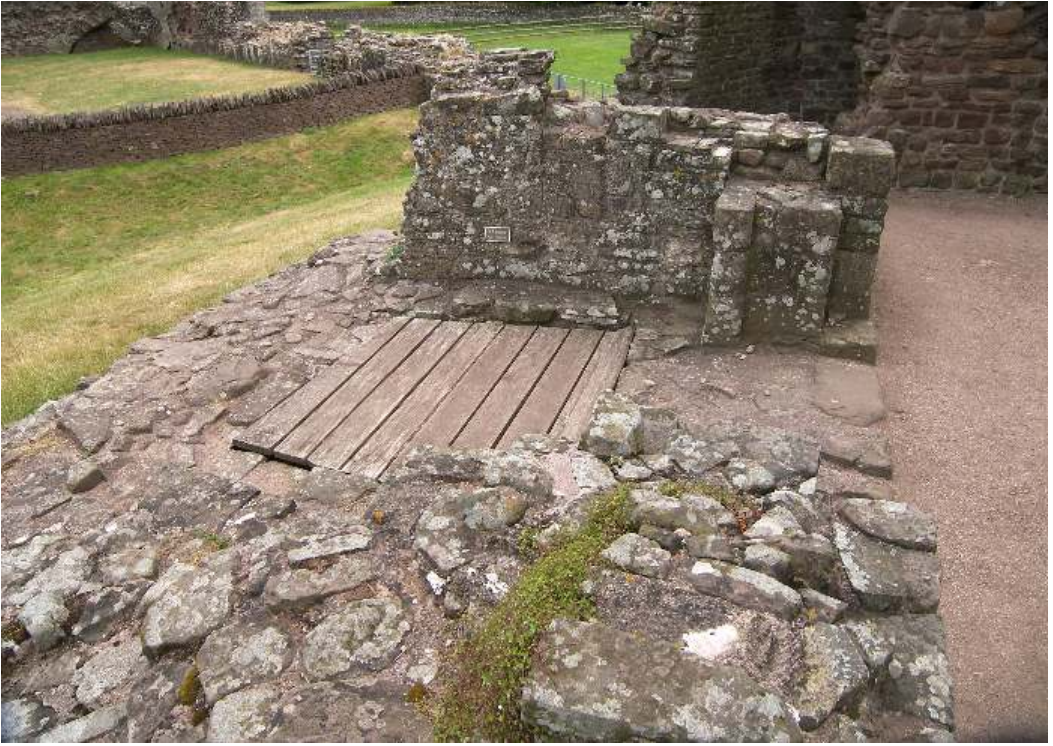
ABOVE: Fig. 10. Entrance to the shell-keep/gatehouse. The pit between two sets of doors. BELOW: Left: Fig. 11. The north-west corner where the outer wall has fallen, once the location of the solar. Right: Fig. 12. The fallen (1947) south-west corner, location of the spiral stair and link between the hall (above) and the solar.

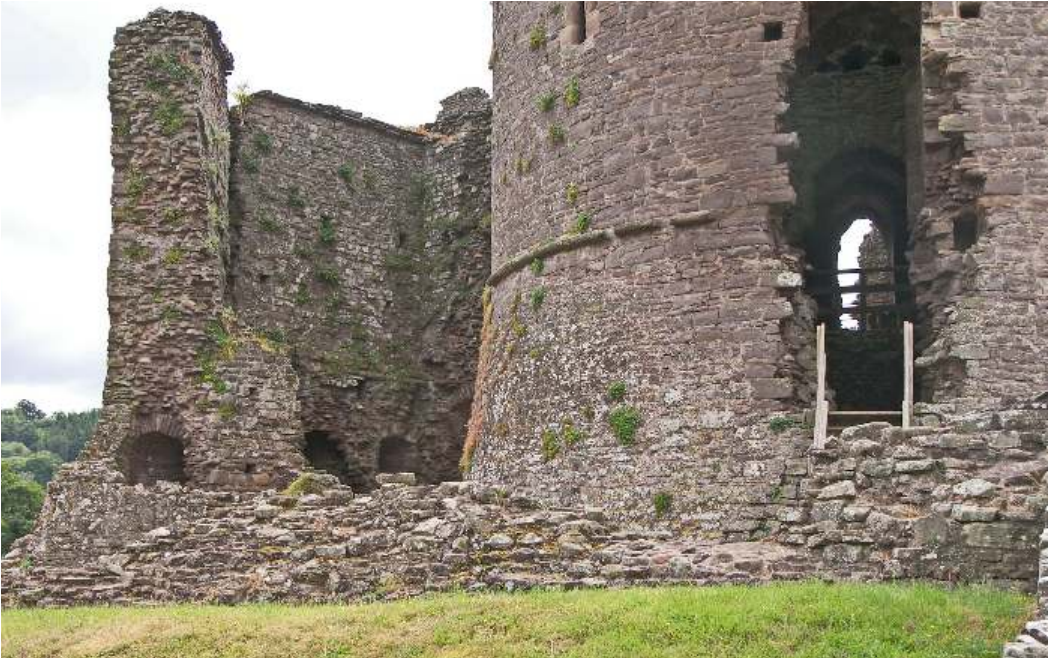
ABOVE: Fig. 13. Shell-keep looking south-west to the entrance (low rubble pile), and the location of the kitchen and hall beyond. BELOW: Fig. 14. Looking east at the fallen south-west corner and (right) the kitchen block with the blocked triangular-headed light.
